Project No: 0352436

Subject: Structural Stability and Safety Factor Assessments – 5-Year Update
Calaveras Power Station
San Antonio, Texas

**Re: Letter Report
Steady State Slope Stability Analysis
Ash Pond Berms - Spruce/Deely Generation Units
San Antonio, Texas**

HTS Project No.: 16-S-303

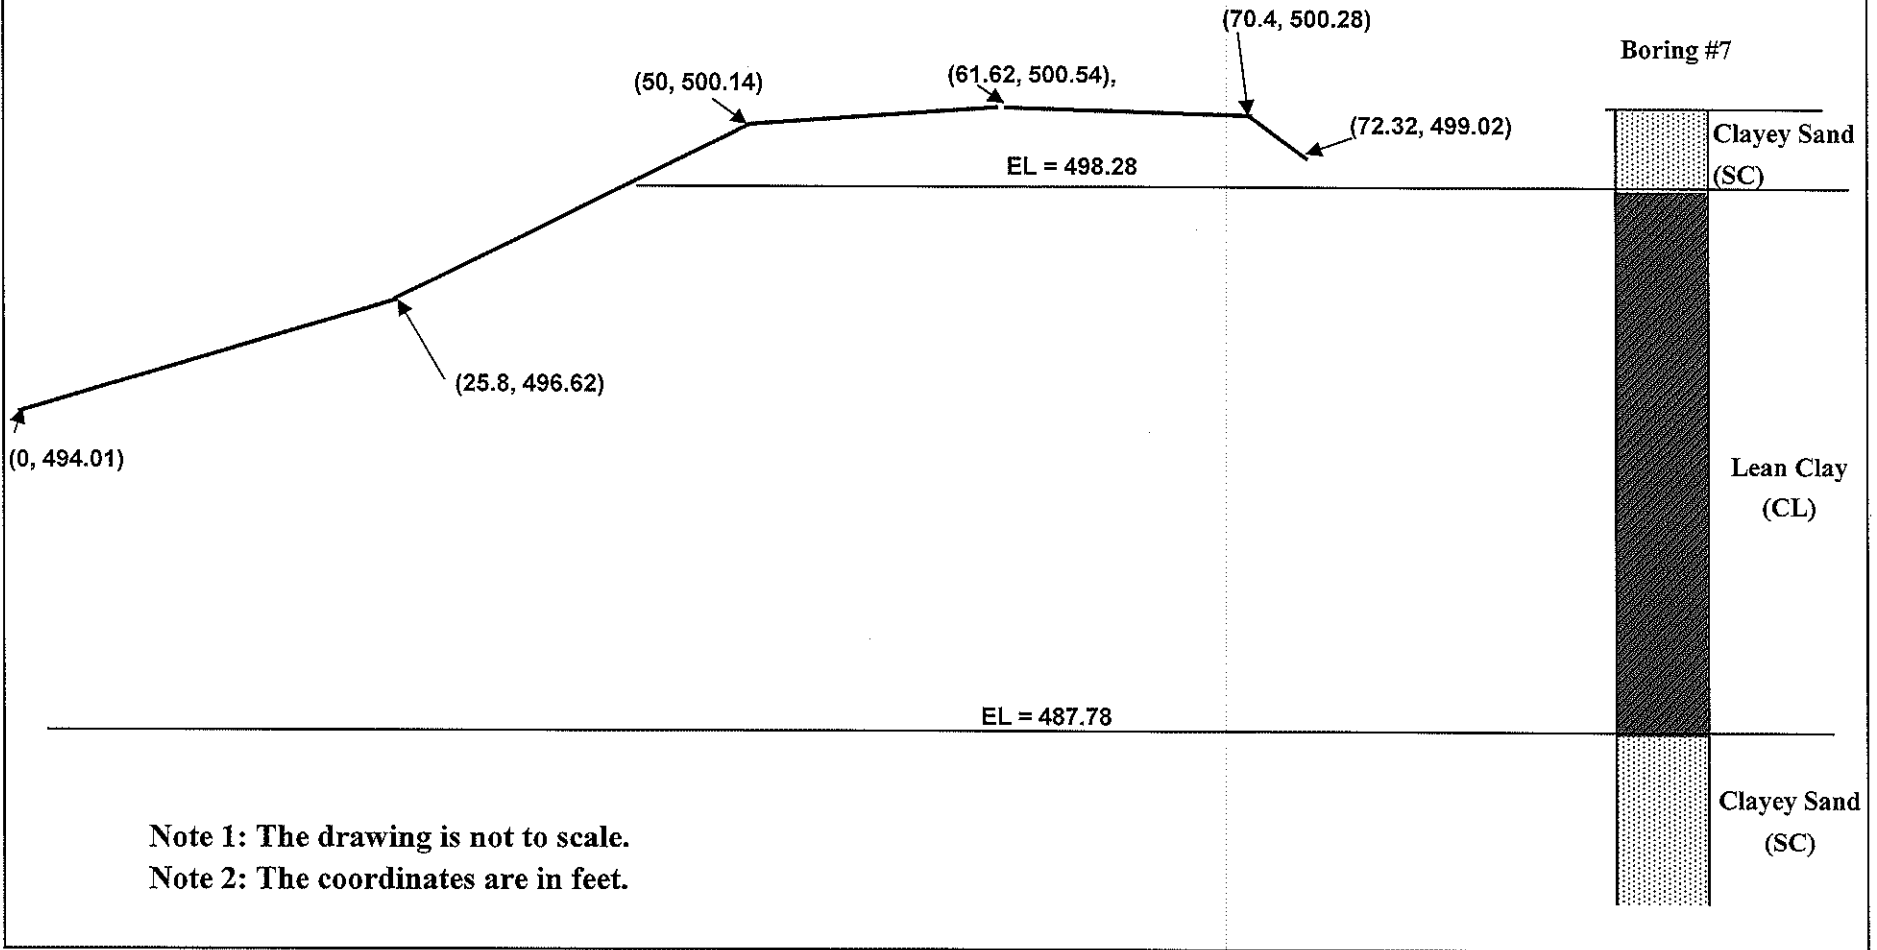
SECTION ALONG CSA

SECTION	FACTOR OF SAFETY (LONG TERM CONDITION)
Section Along CSA	4.06
Section Along CSB	4.08

Typical Section Configuration for Slope Stability Analyses - Section Along CSA

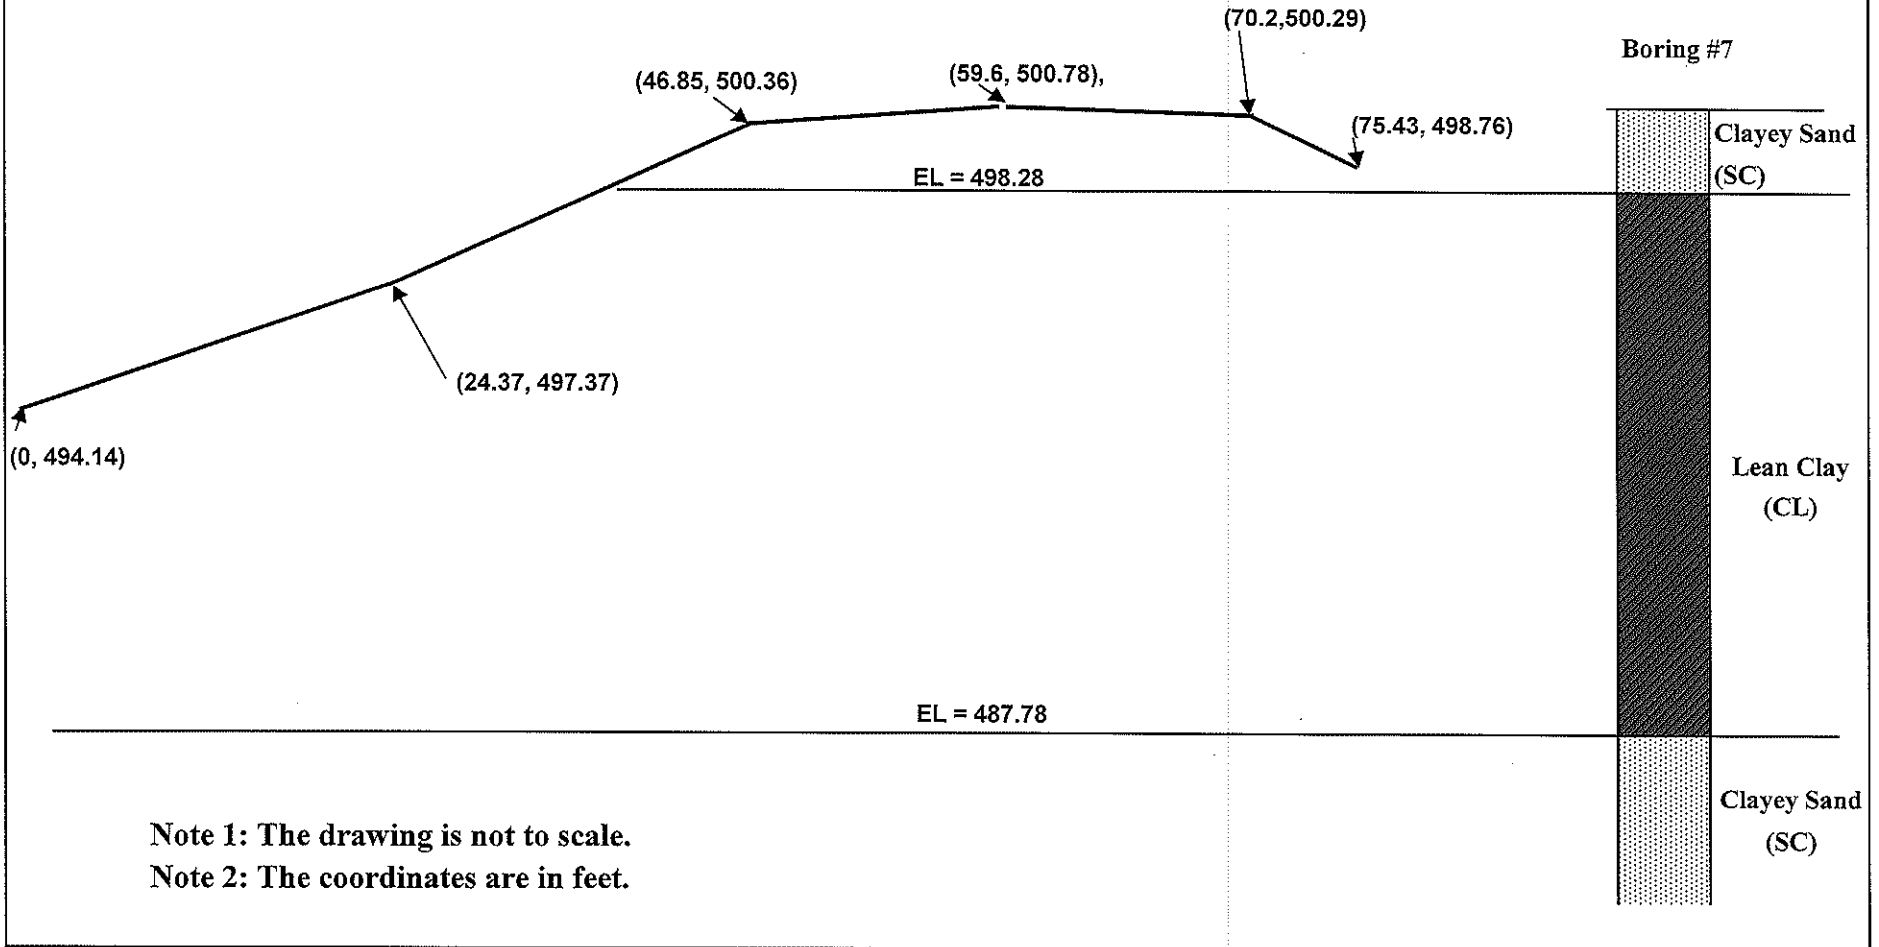
SECTION ALONG CSB

Typical Section Configuration for Slope Stability Analyses - Section Along CSB		
Steady State Slope Stability Analysis Ash Pond Berms - Spruce/Deely Generation Units San Antonio, Texas		
Date: 7/18/16	HTS Proj No.: 16-S-303	Plate 2

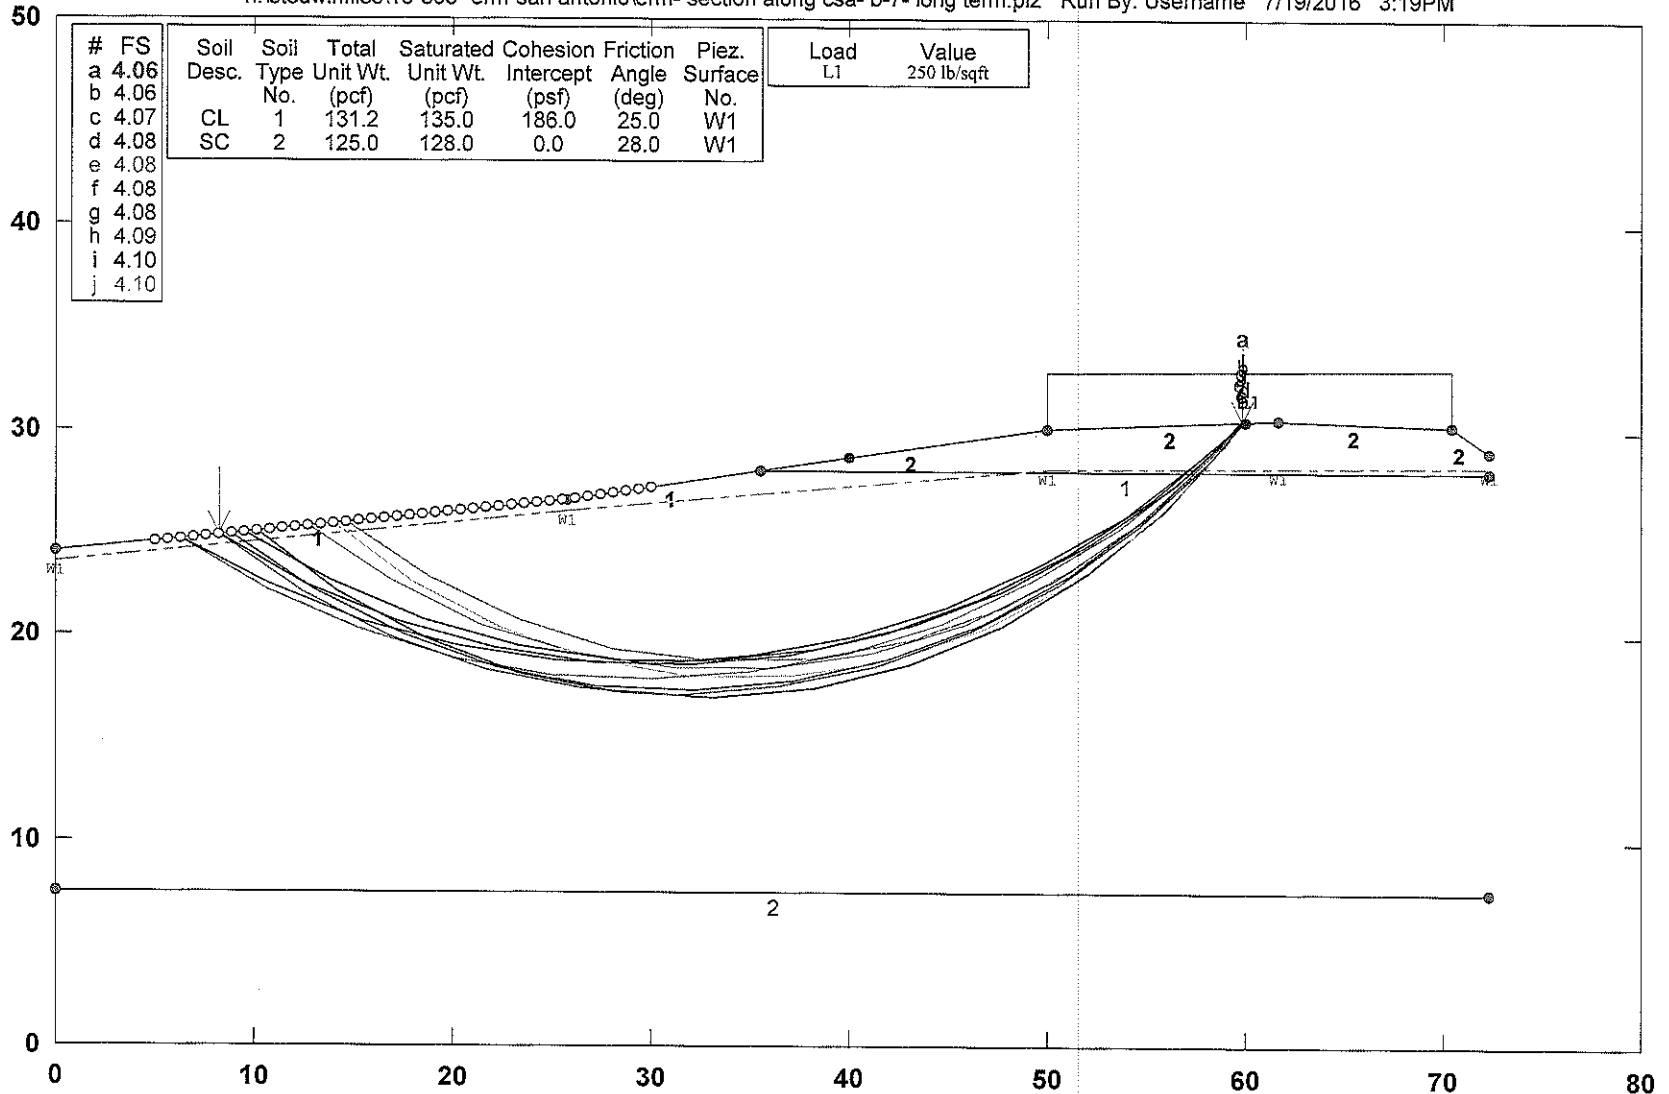
Ash Pond Berms - Spruce/Deely, B-7 Long Term, CSA

The results of the stability analyses using the shear strength parameters as discussed above suggest that the slopes of the section configurations provided by ERM will be stable in the long term condition.

STABL6H FSmin=4.06

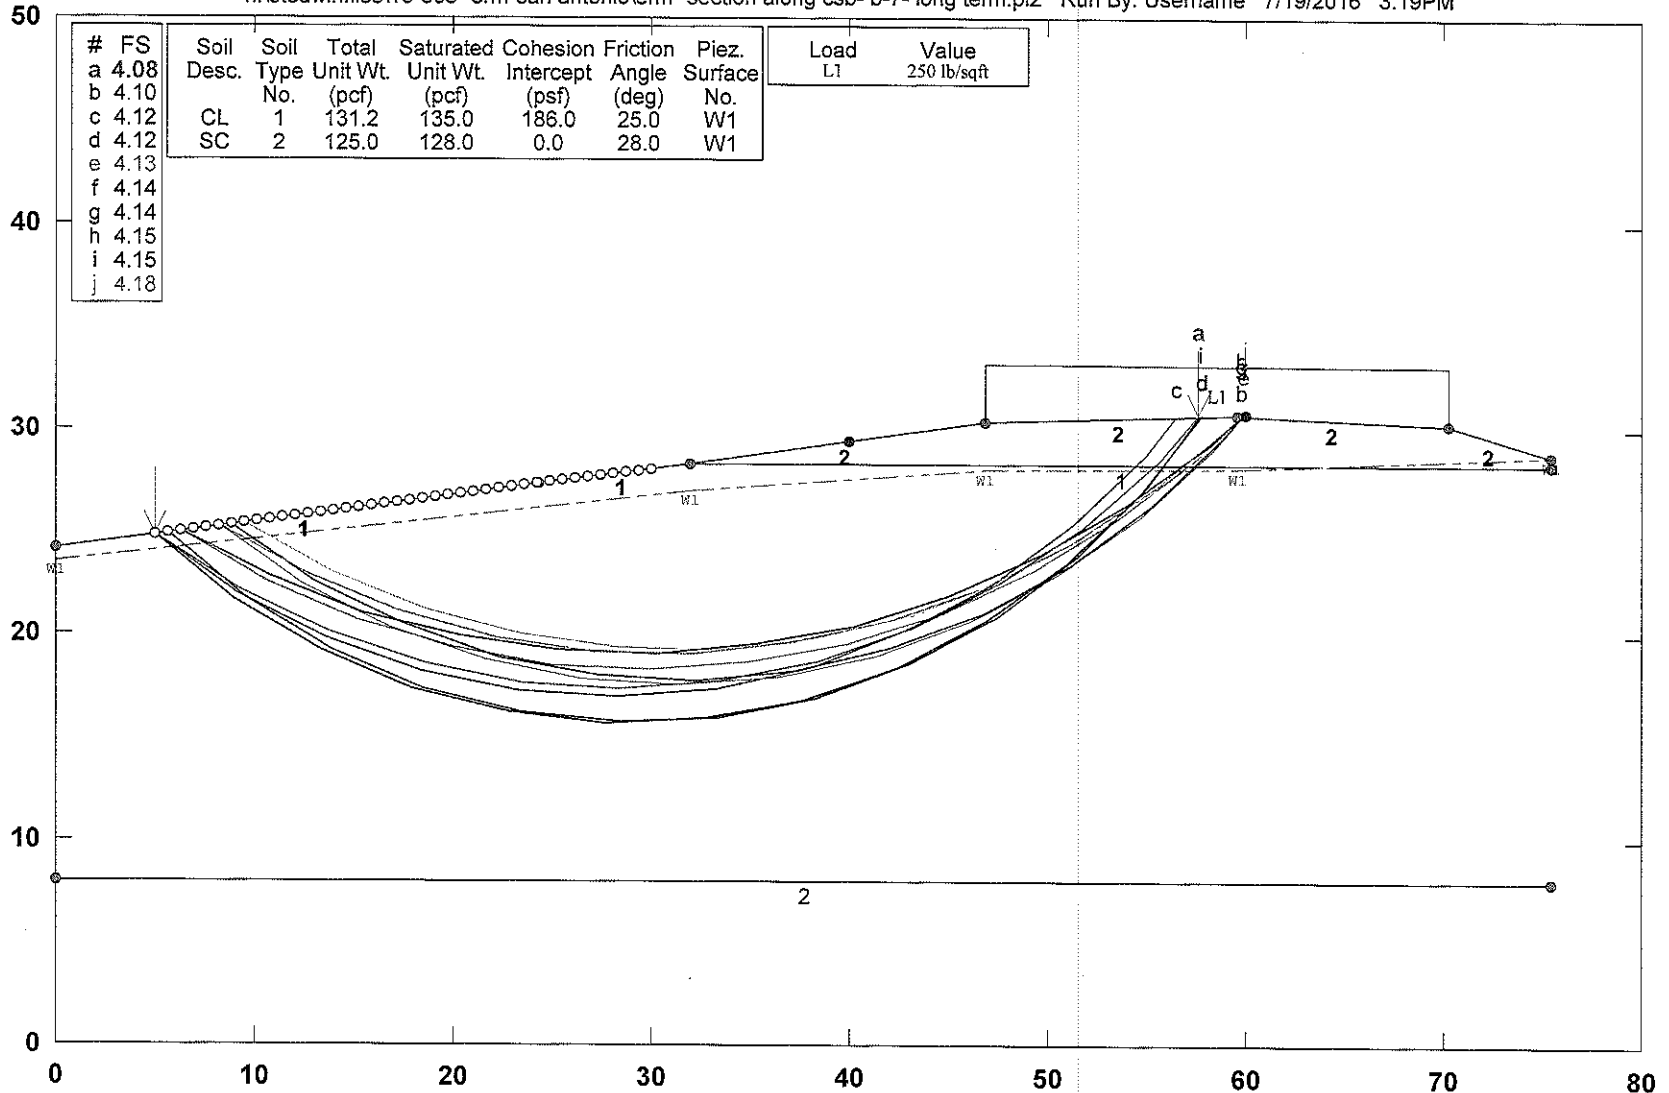
Ash Pond Berms - Spruce/Deely, B-7 Long Term, CSB

STABL6H FSmin=4.08
