January 16, 2020

Project No. 0352436

Subject: CCR Units - 2019 Annual Inspection and Fugitive Dust
Control Report
Calaveras Power Station
San Antonio, Texas

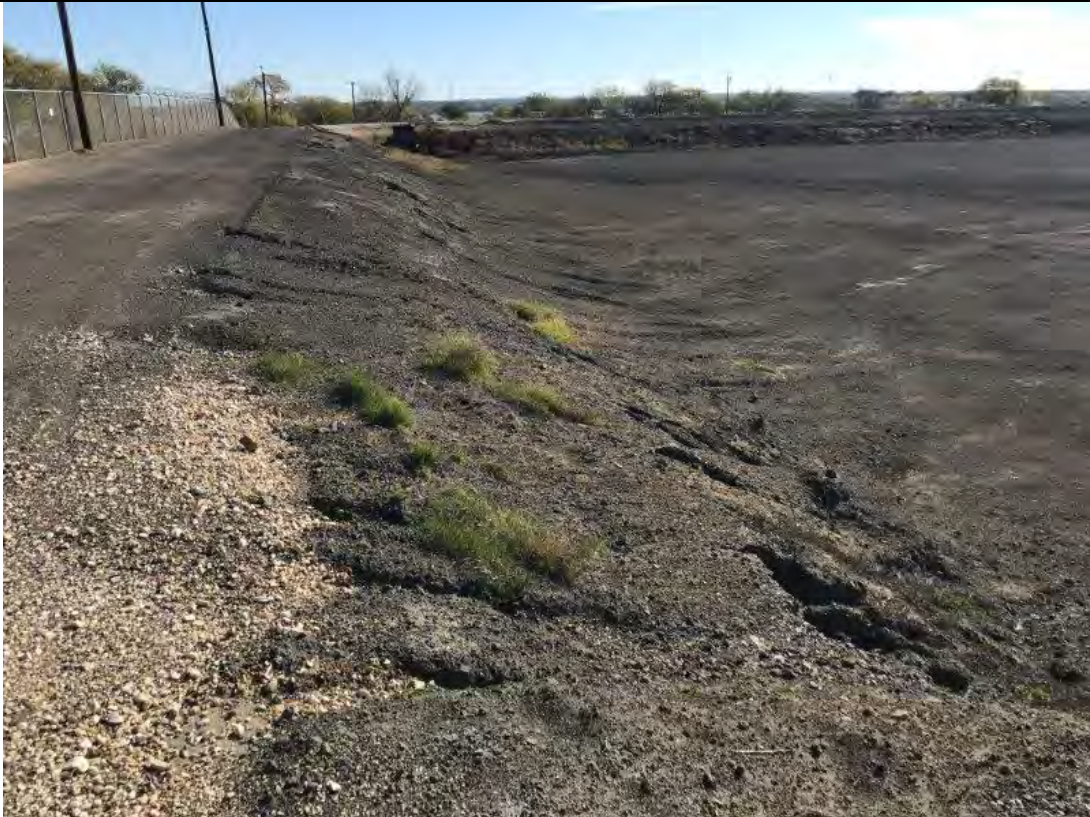
Grass along the western and eastern exterior embankment slopes was observed to be generally well maintained. Some woody plant growth was observed on the north exterior embankment slope and some minor erosion was observed on the north interior embankment slope. Corrosion was observed on the overflow discharge pipe and nearby sheet piling. No significant rutting, erosion, animal burrows, seepage, or other problems were observed at the time of the annual inspection.

Photograph: 13 North Bottom Ash Pond – standing on northwest corner – facing east. Minor erosion observed on interior slopes. Photo taken 12/19/2019.

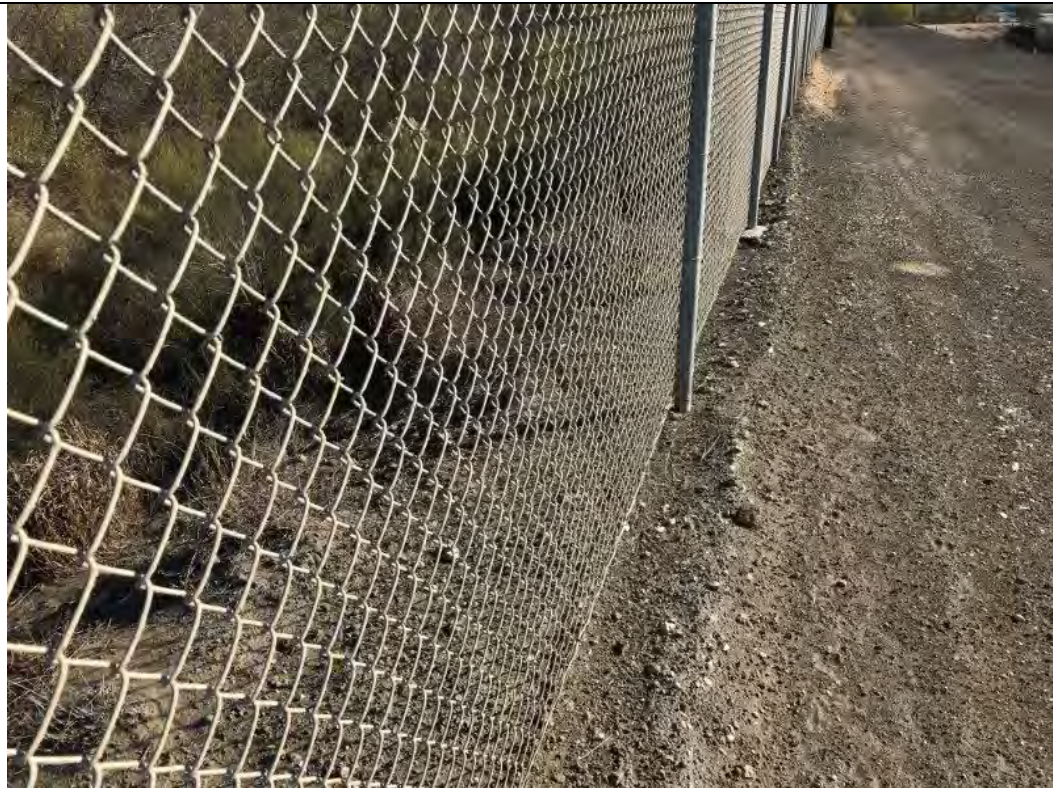
Photograph: 15 North Bottom Ash Pond – standing on north berm – facing east and down. Woody plant growth noted on north berm exterior side slope. Photo taken 12/19/2019.

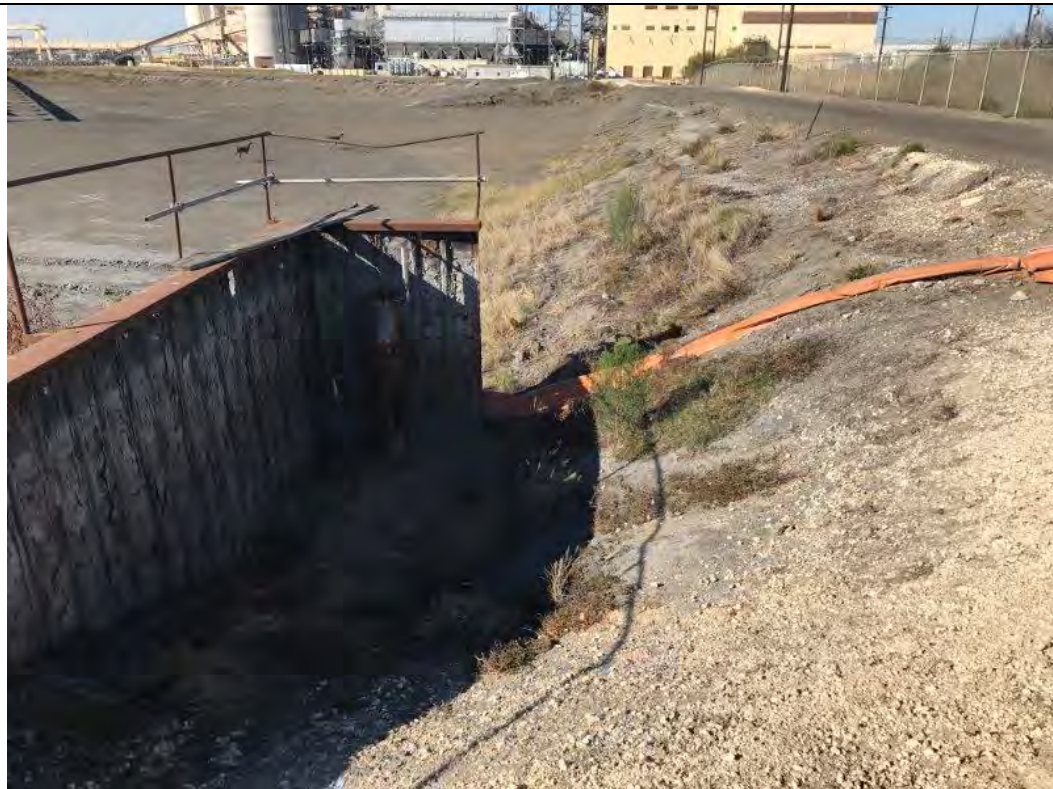
Photograph: 16 North Bottom Ash Pond – standing on northwest corner – facing east. Photo taken 12/19/2019. Corrosion observed in vertical overflow pipe and sheet piling.

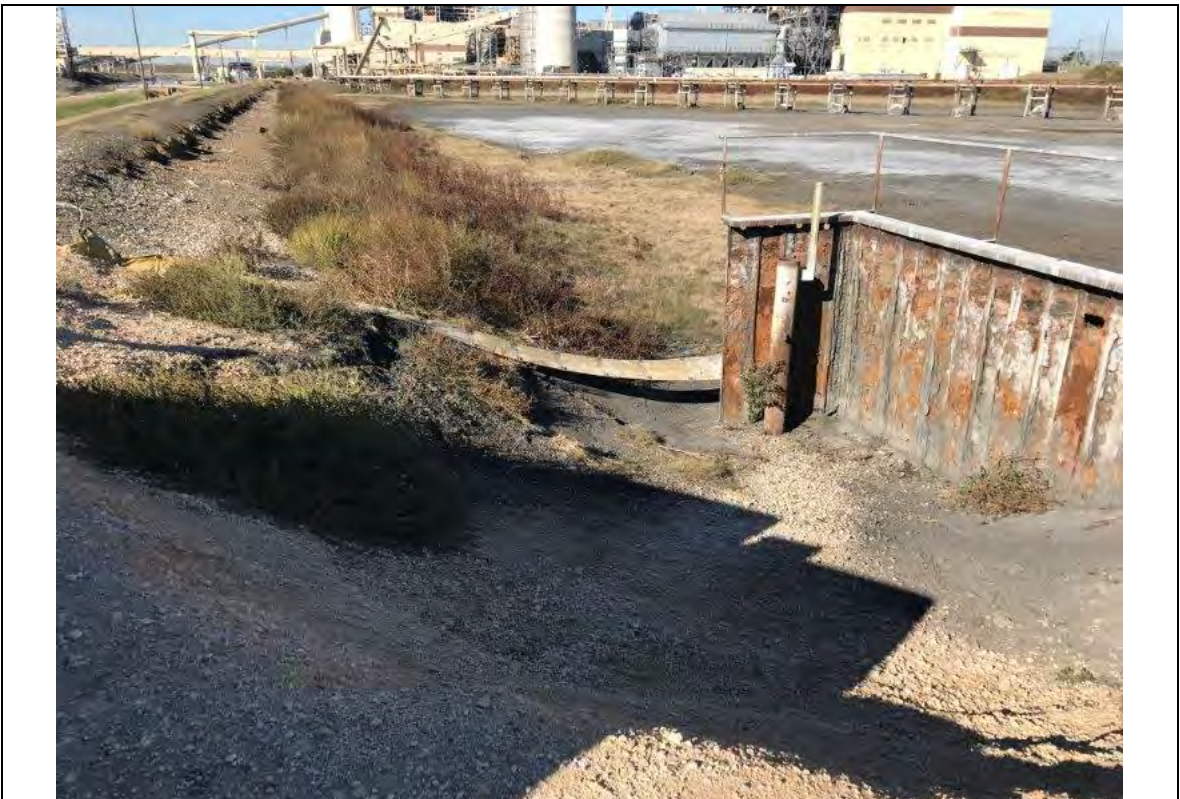
Grass along the external embankment slopes was observed to be generally well maintained and no woody plants were observed. Corrosion was observed on the overflow discharge pipe and nearby sheet piling. No significant rutting, erosion, animal burrows, seepage, or other problems were observed at the time of the annual inspection.

Photograph: 22 South Bottom Ash Pond – standing on southeast corner – facing west. Corrosion observed in vertical overflow pipe and sheet piling. Photo taken 12/19/2019.

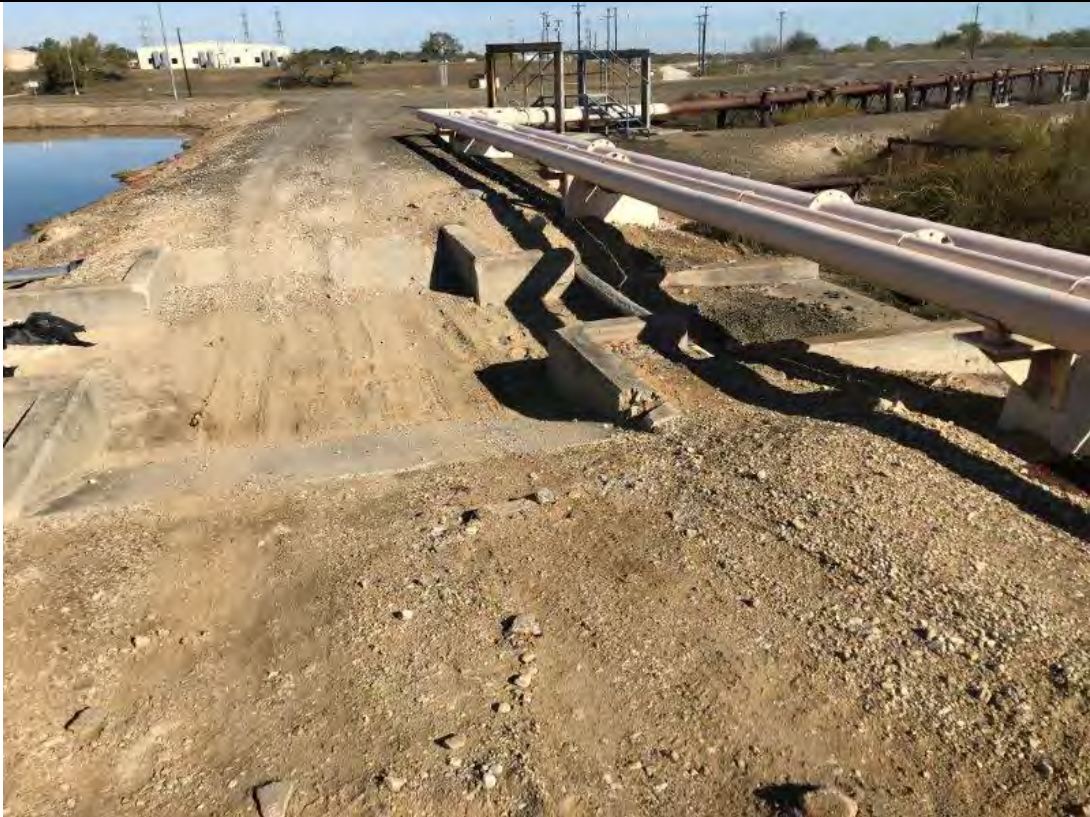
Grass along the external embankment slopes was observed to be generally well maintained. No significant rutting, erosion, animal burrows, seepage, or other problems were observed at the time of the annual inspection. Spillways that flow to the South BAP appeared partially obstructed with sand and plastic sheeting. The spillways will need to be evaluated before the South BAP undergoes closure.

Photograph: 25 North SRH Pond – standing on eastern berm – facing north. Spillway structure. Photo taken 12/19/2019.

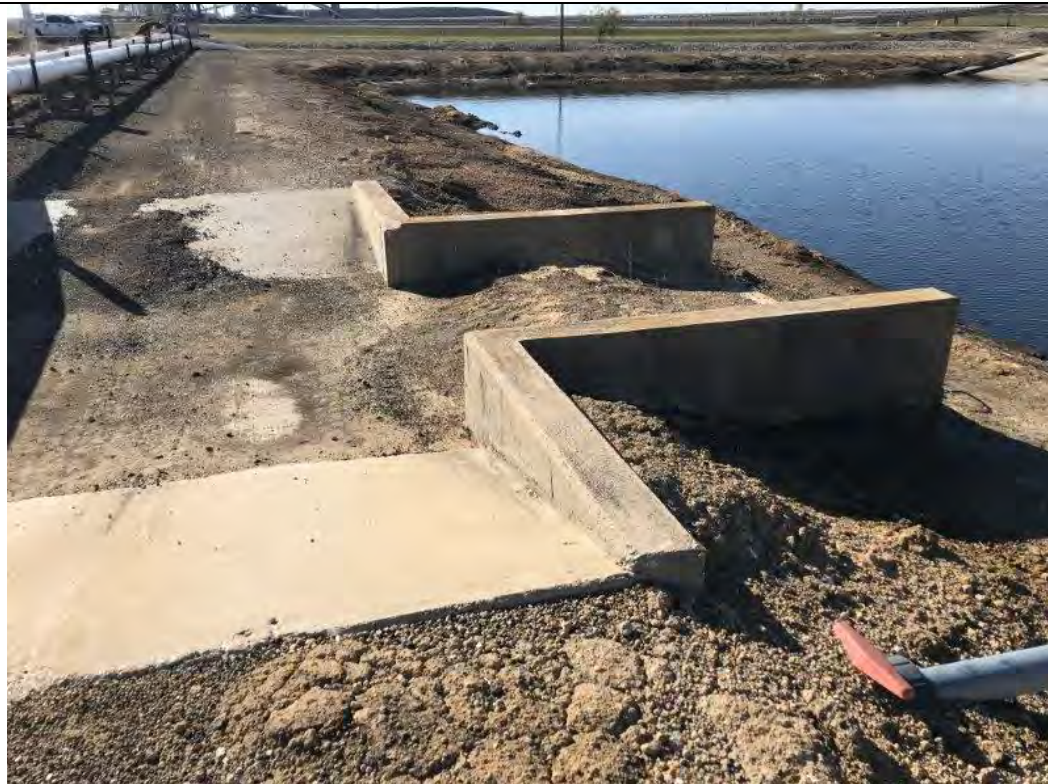
Photograph: 33 South SRH Pond – standing on the eastern berm – facing south. Spillway structure. Photo taken 12/19/2019.
