Project No. 0352436

Subject: CCR Units – 2020 Annual Inspection and Fugitive Dust  
Control Report  
Calaveras Power Station  
San Antonio, Texas

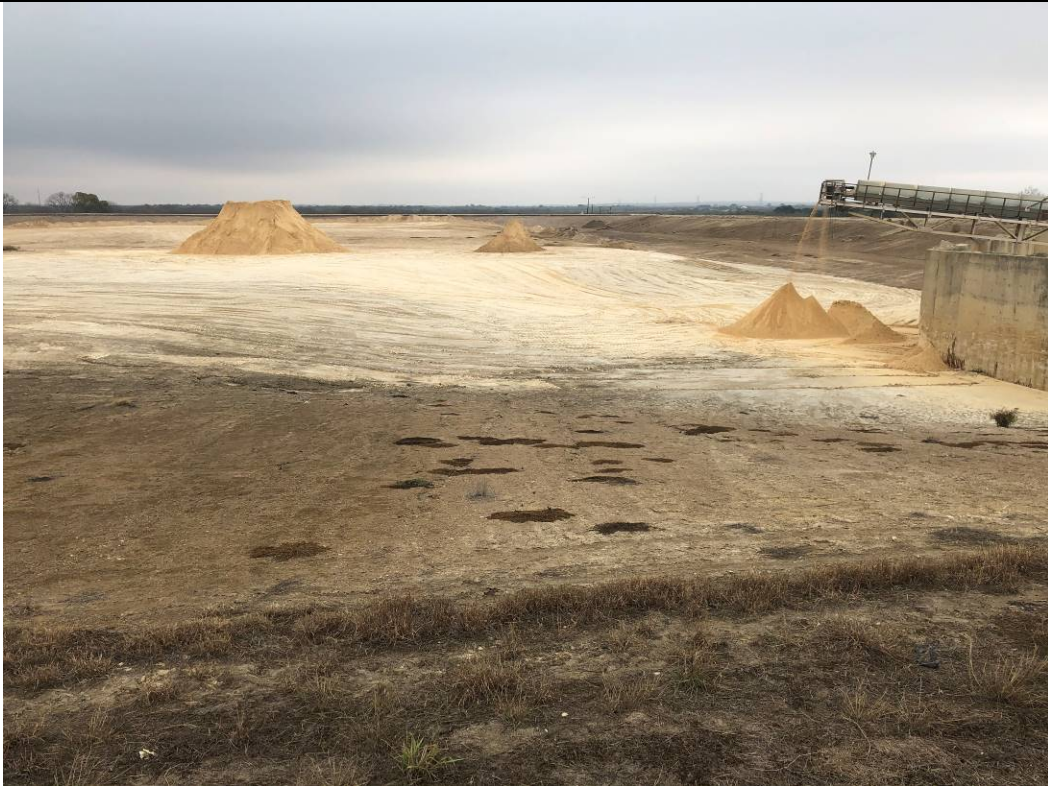
**Photograph: 1** Fly Ash Landfill – standing on west berm – facing east. Radial stacker located in southwest corner of landfill. Photo taken 12/15/2020.

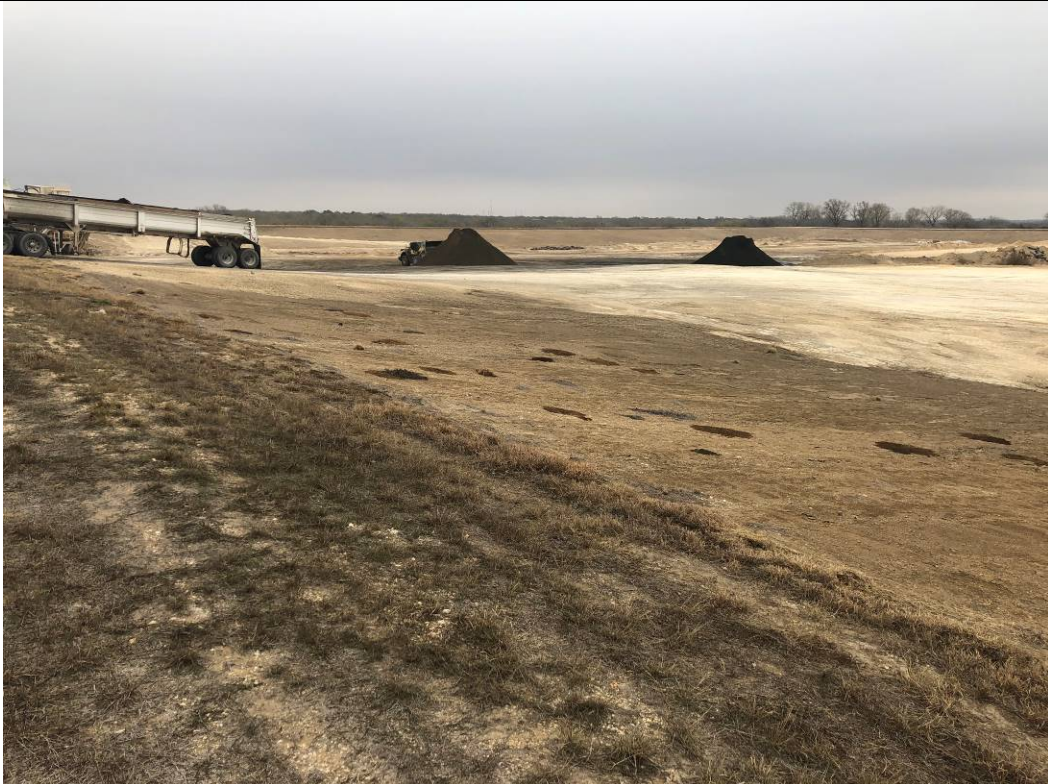
**Photograph: 2** Fly Ash Landfill – standing on west berm – facing northeast. Photo taken 12/15/2020.

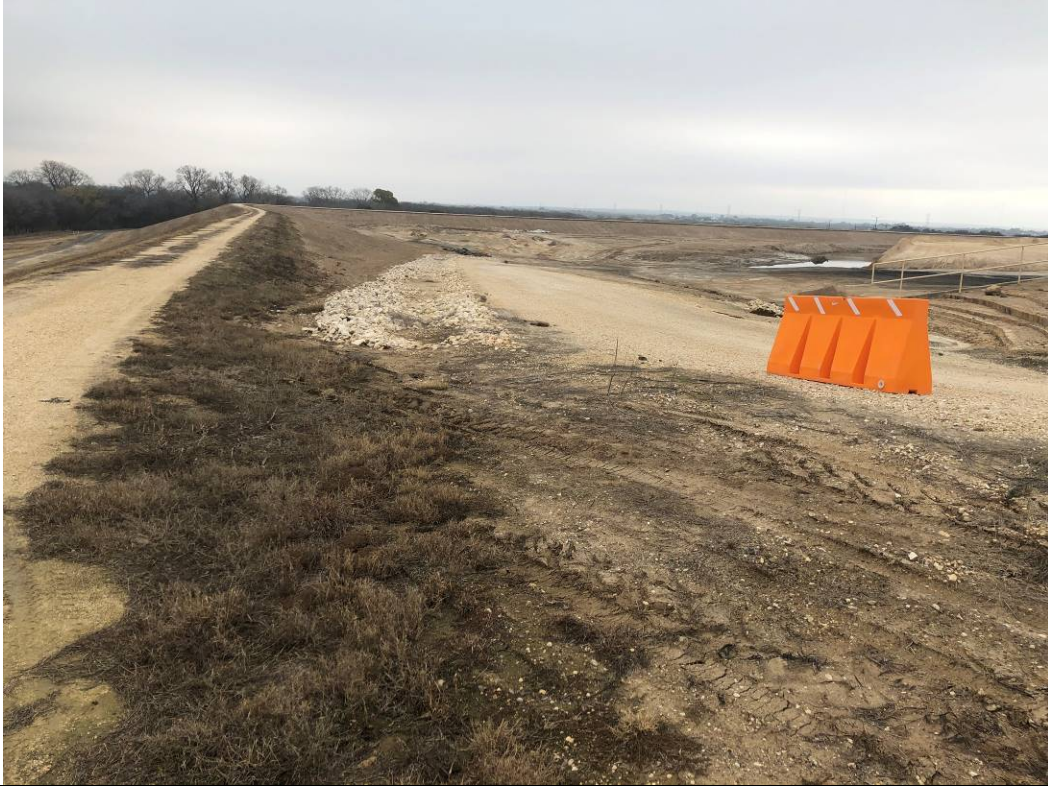
**Photograph: 3** Fly Ash Landfill – standing on northwest corner – facing west. Photo taken 12/15/2020.

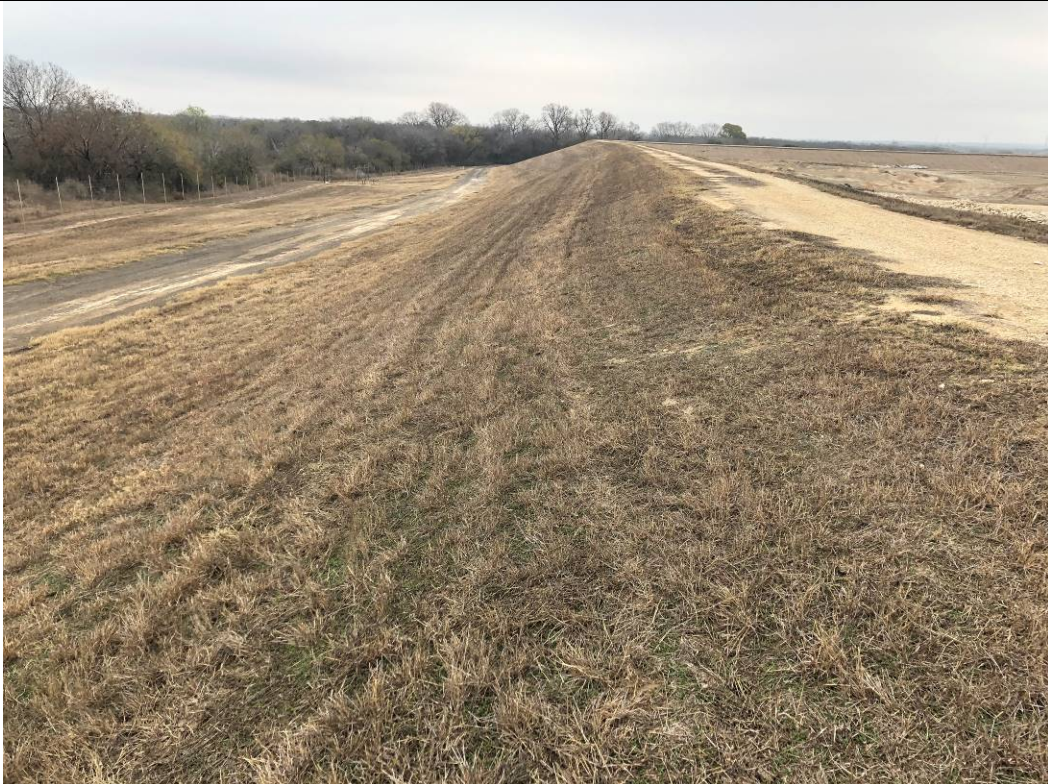
**Photograph: 4** Fly Ash Landfill – standing on northwest corner – facing west. Photo taken 12/15/2020.

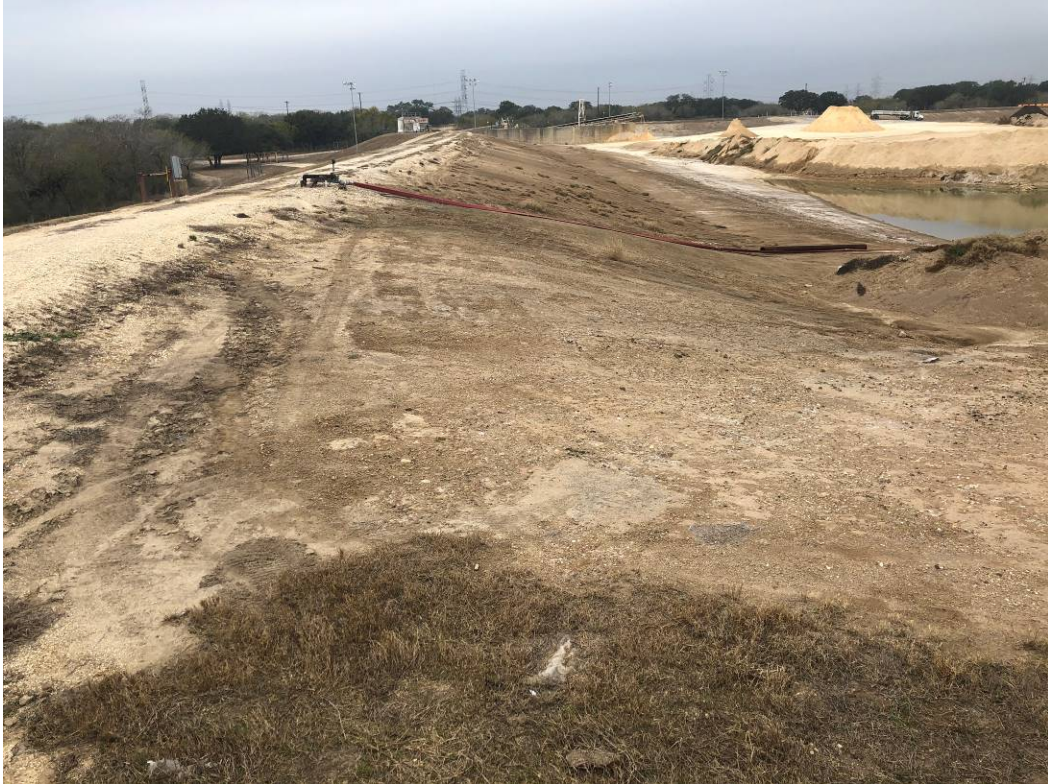
**Photograph: 5** Fly Ash Landfill – standing on southeast corner – facing west. Radial stacker located in southwest corner and stormwater discharge piping in southeast corner of landfill. Photo taken 12/15/2020.

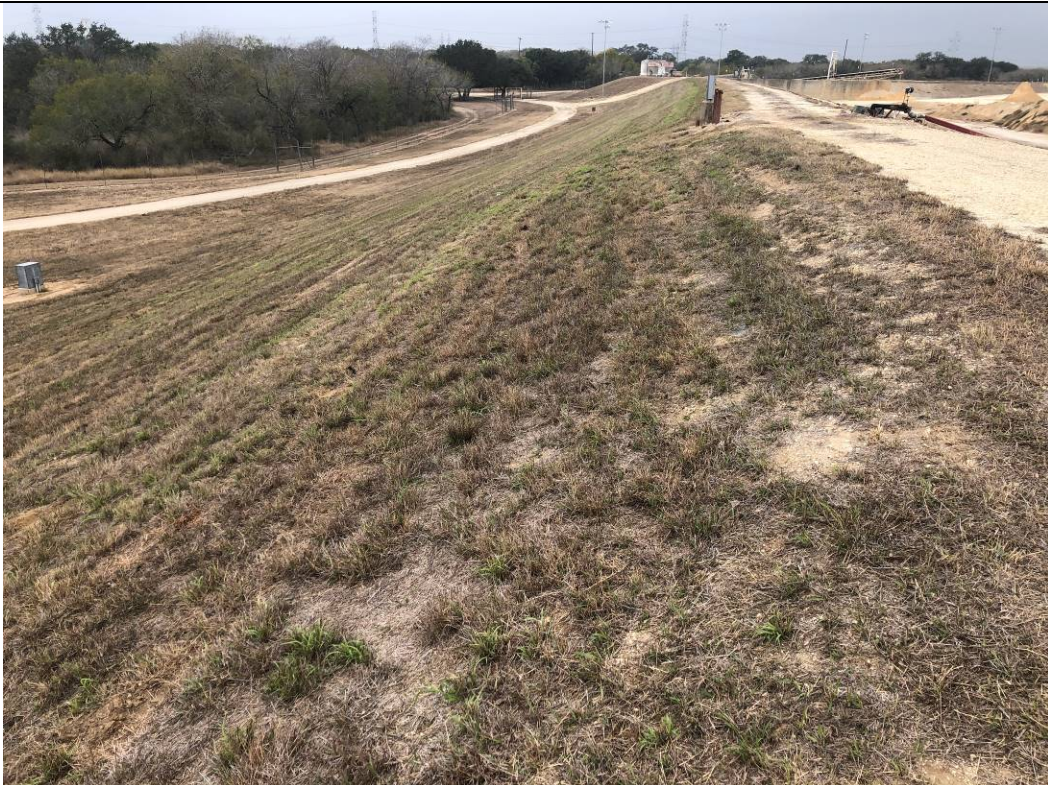
**Photograph: 6** Fly Ash Landfill – standing on southeast corner – facing west. Radial stacker located in southwest corner and stormwater discharge piping in southeast corner of landfill. Photo taken 12/15/2020.

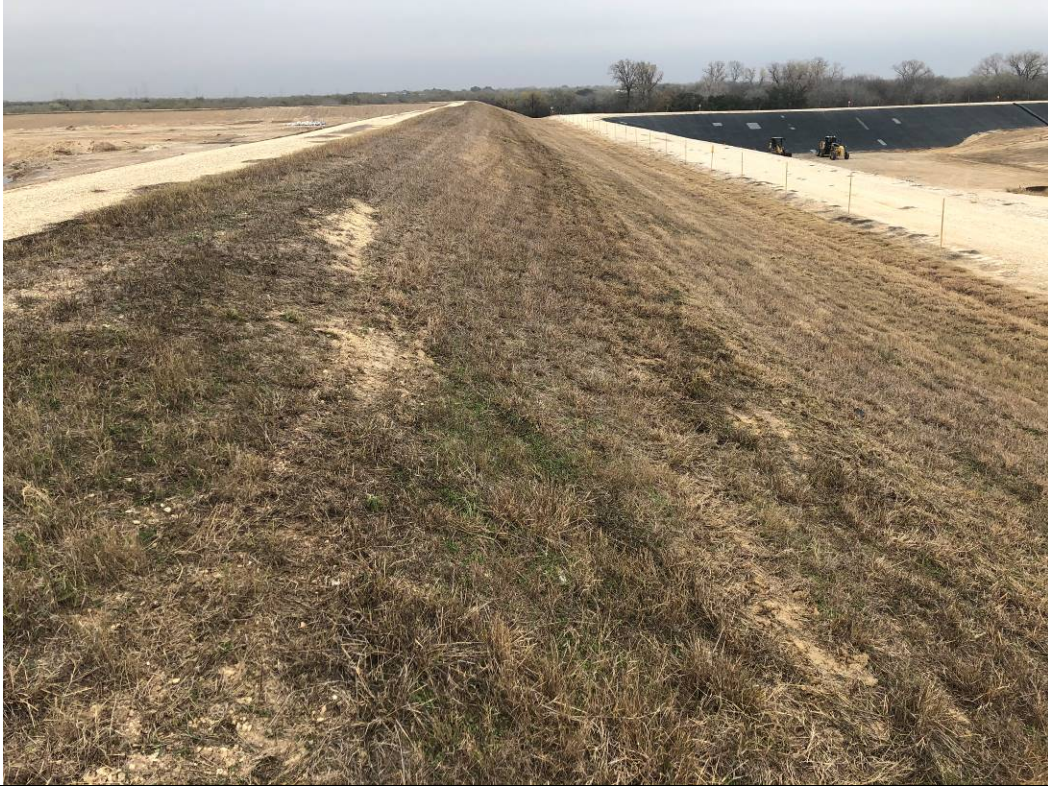
**Photograph: 7** Fly Ash Landfill – standing on southeast corner – facing north. Photo taken 12/15/2020.

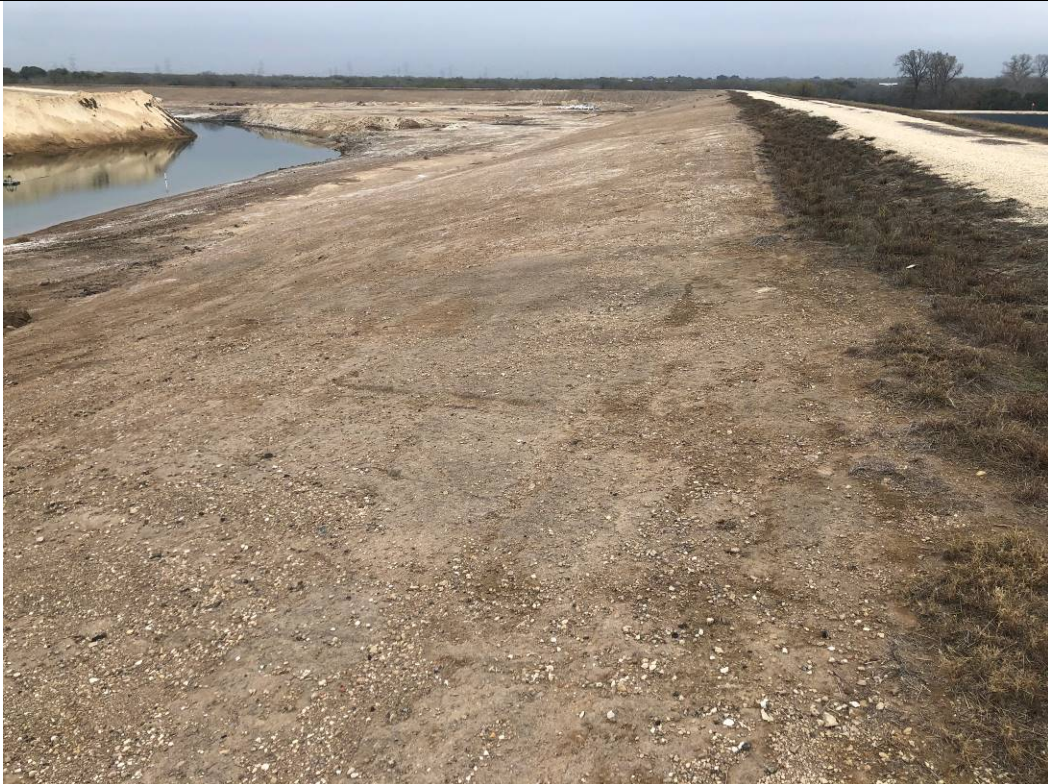
**Photograph: 8** Fly Ash Landfill – standing on southeast corner – facing north. Photo taken 12/15/2020.

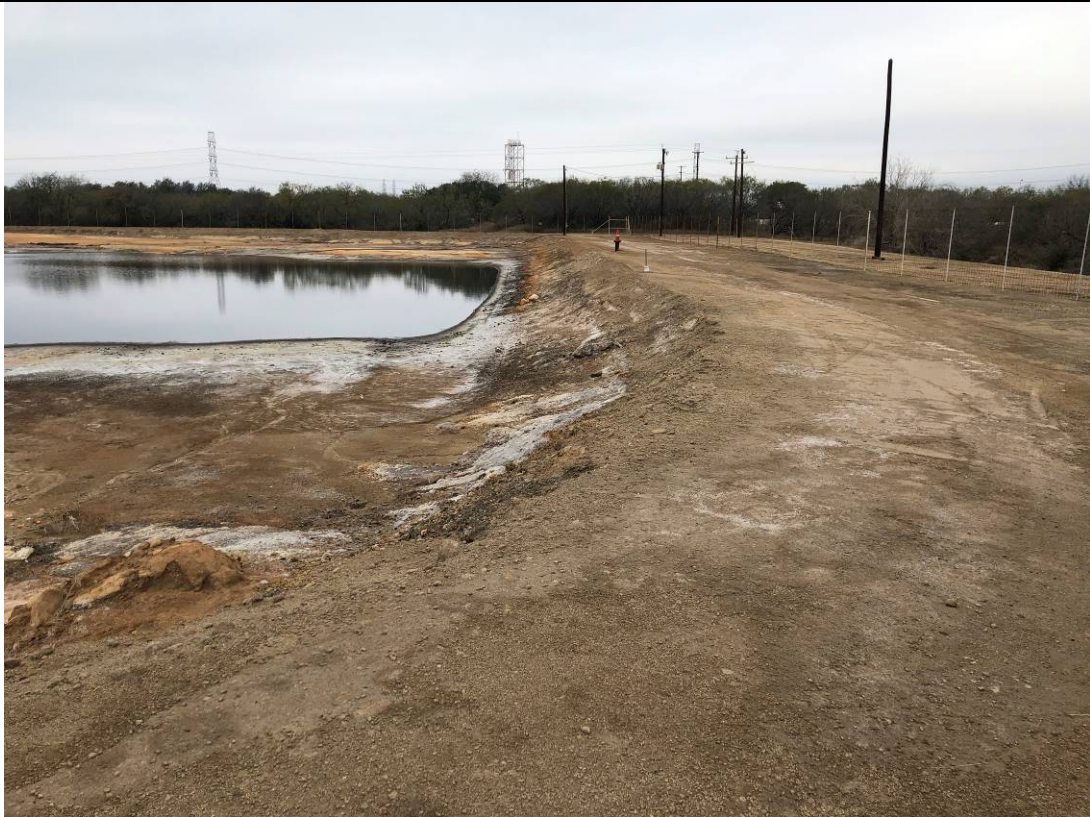
**Photograph: 9** | Evaporation Pond – standing on the northeast corner – facing west. Photo taken 12/15/2020.

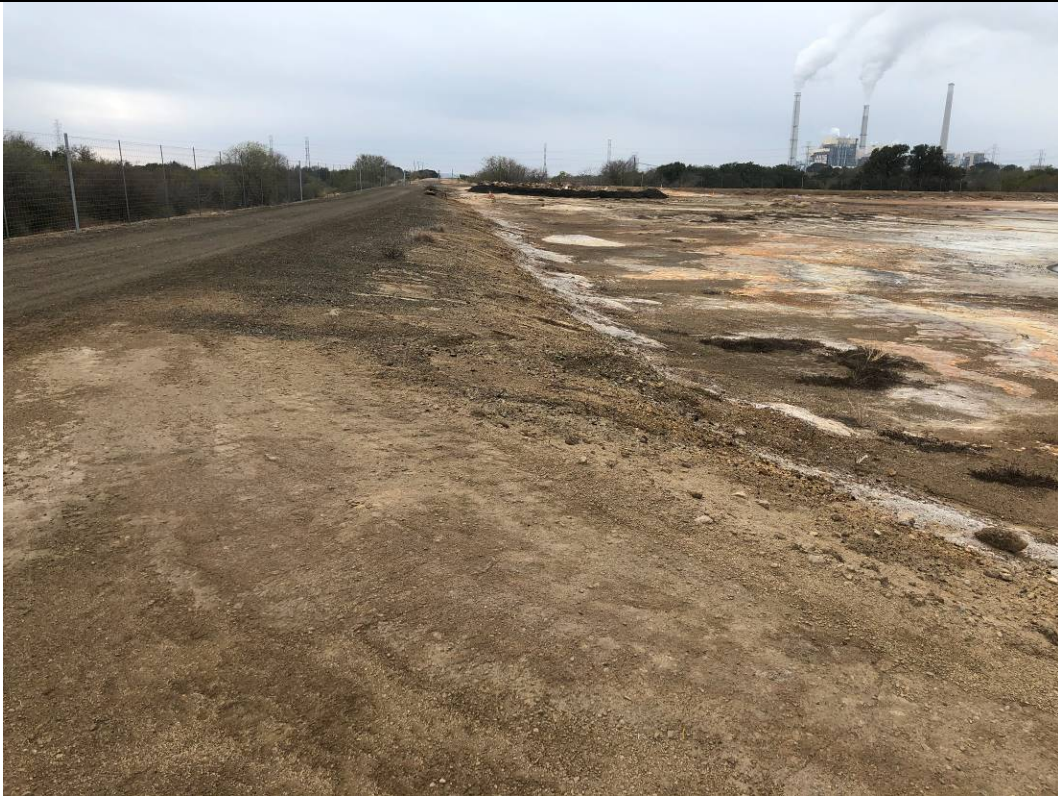
**Photograph: 10** | Evaporation Pond – standing on the northeast corner – facing south. Photo taken 12/15/2020.

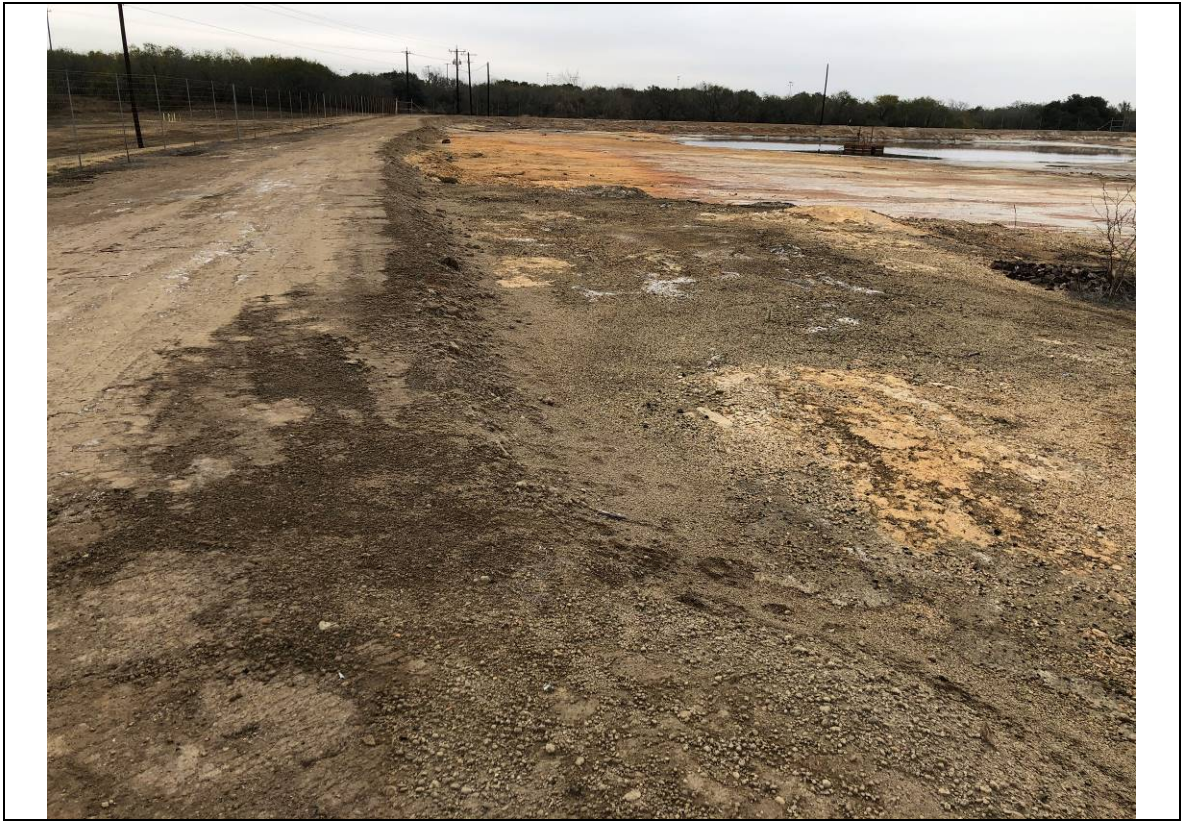
**Photograph: 11** | Evaporation Pond – standing on the southwest corner – facing north.  
Photo taken 12/15/2020.

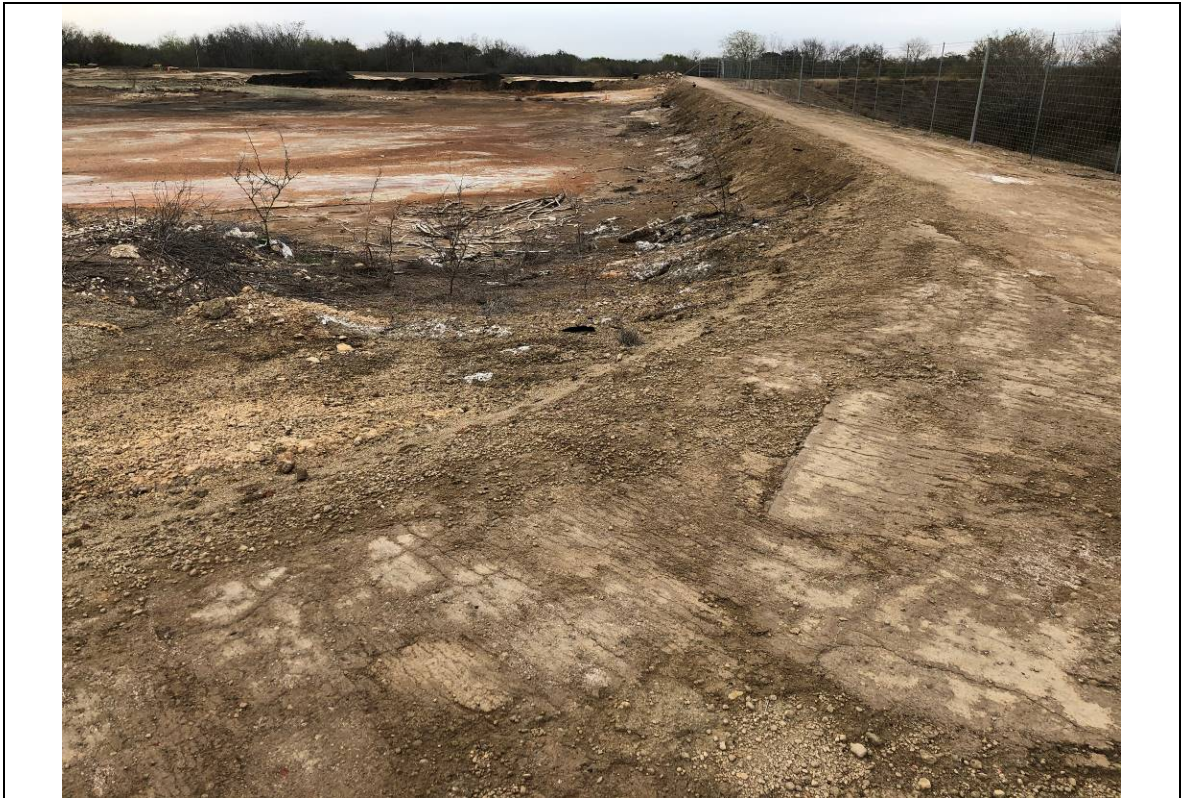
**Photograph: 12** | Evaporation Pond – standing on the southwest corner – facing east. Photo taken 12/15/2020.

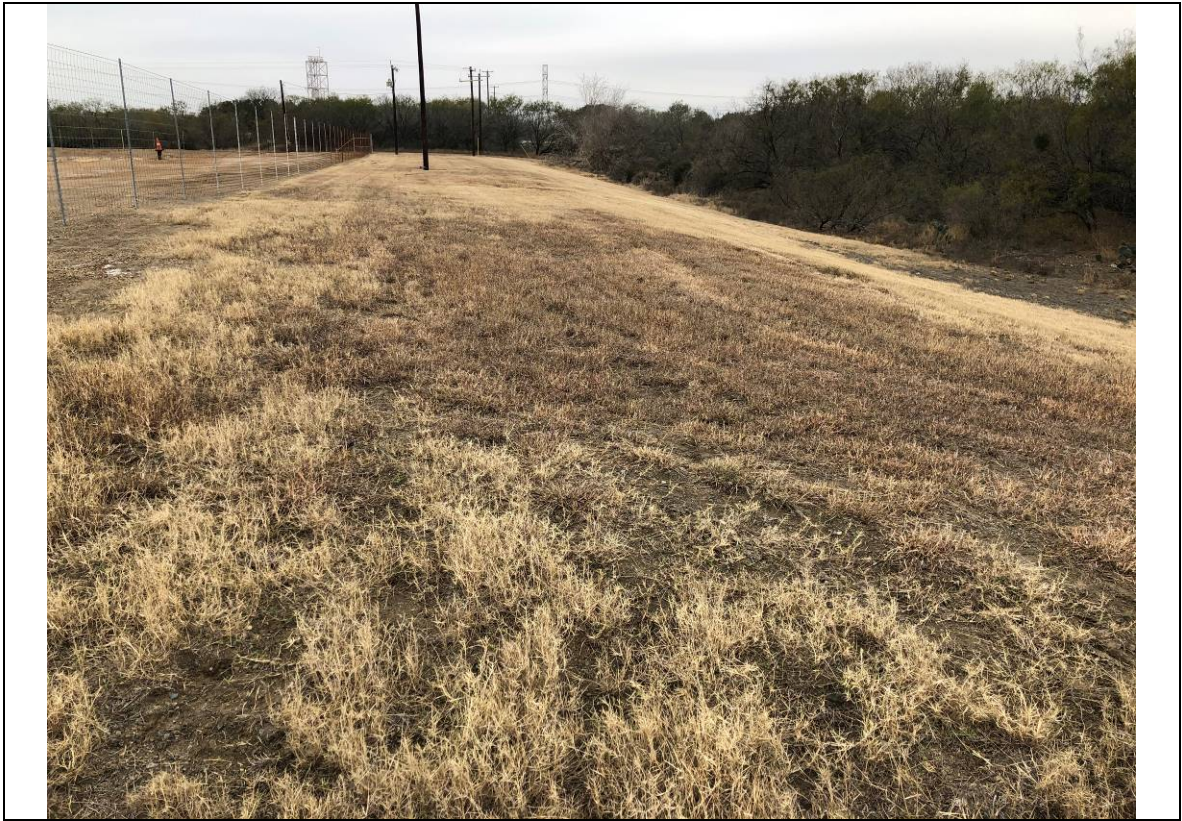
**Photograph: 13** | Evaporation Pond – standing on the northeast corner – facing west. Photo taken 12/15/2020.

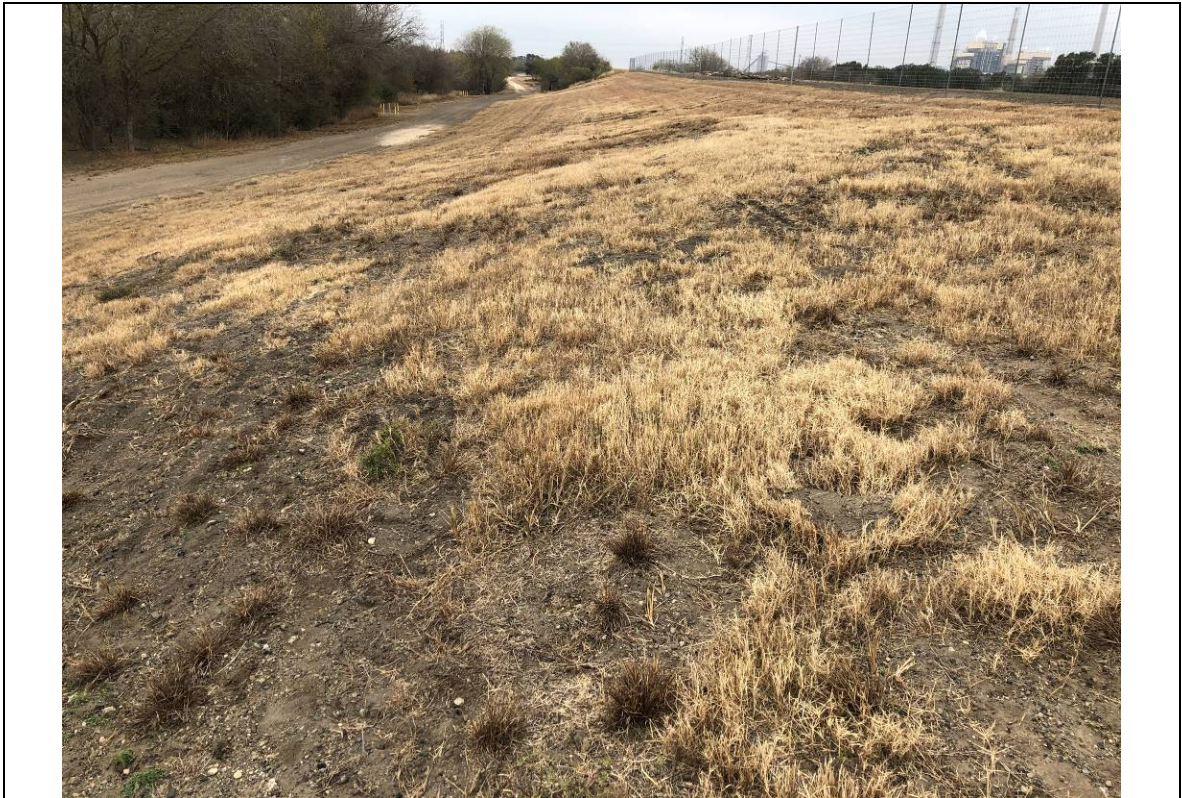
**Photograph: 14** | Evaporation Pond – standing on the northeast corner – facing south. Photo taken 12/15/2020.

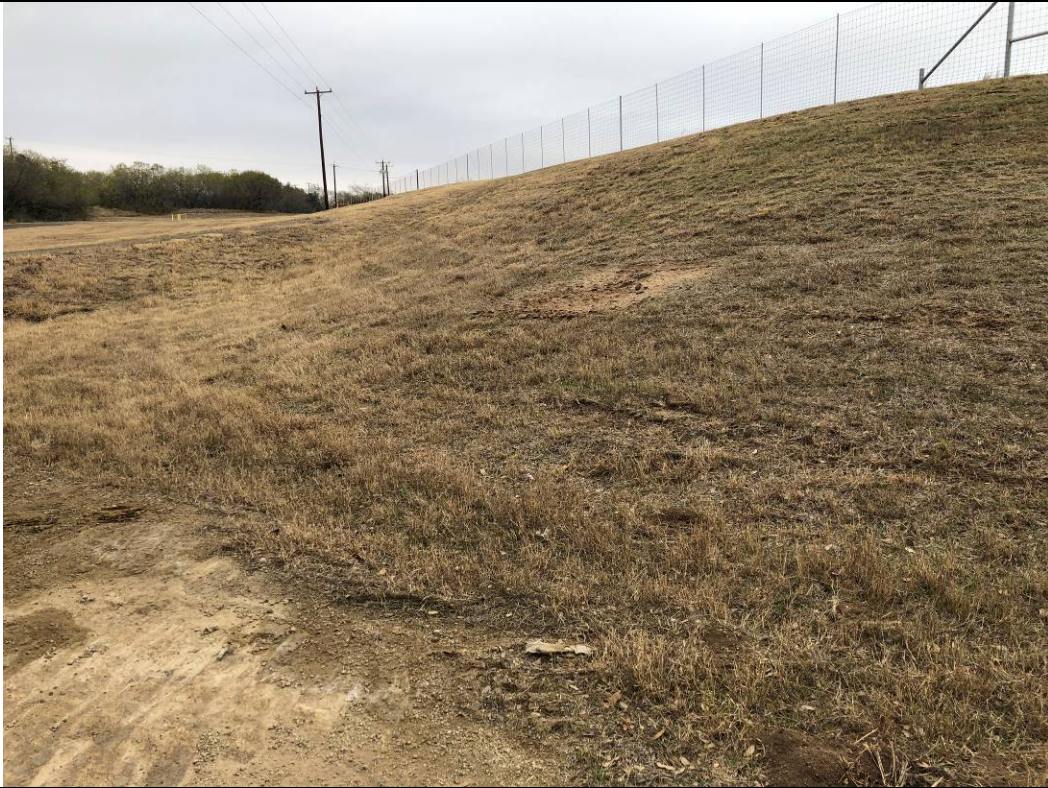
**Photograph: 15** Evaporation Pond – standing on the southwest corner – facing north. Photo taken 12/15/2020.

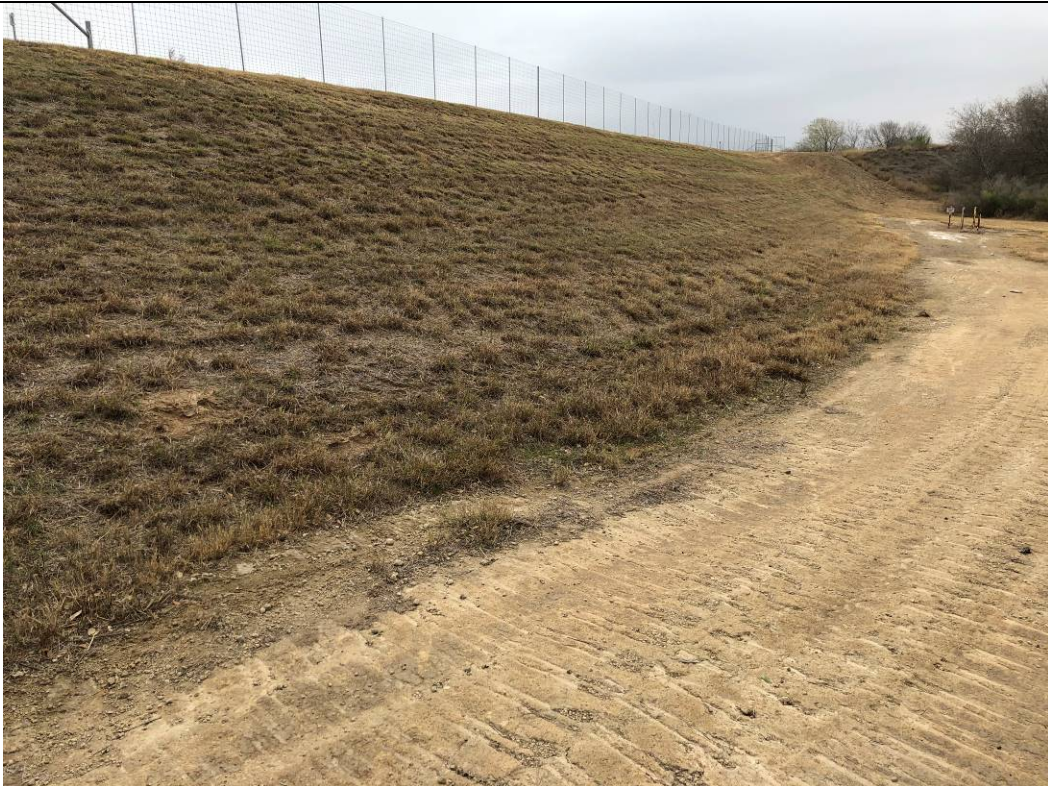
**Photograph: 16** Evaporation Pond – standing on the southwest corner – facing east. Photo taken 12/15/2020.

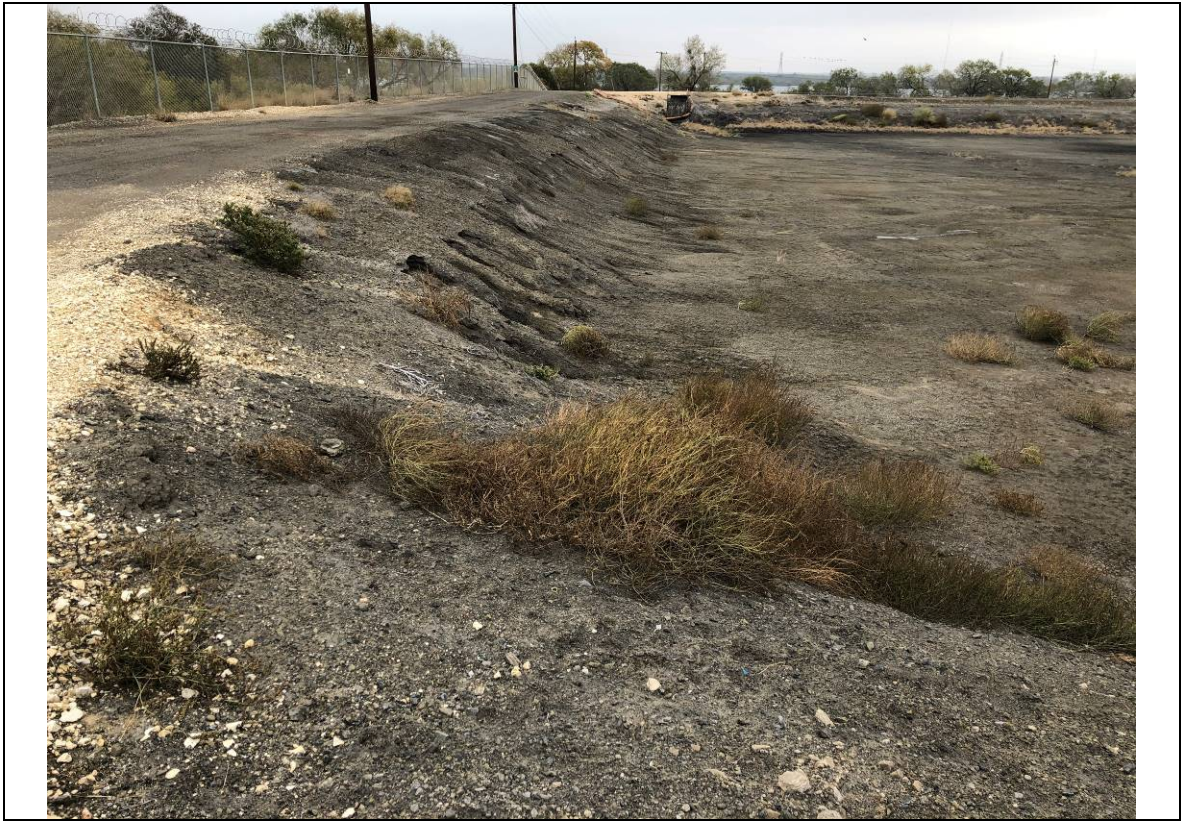
**Photograph: 17** North Bottom Ash Pond – standing on northwest corner – facing east. Photo taken 12/15/2020.

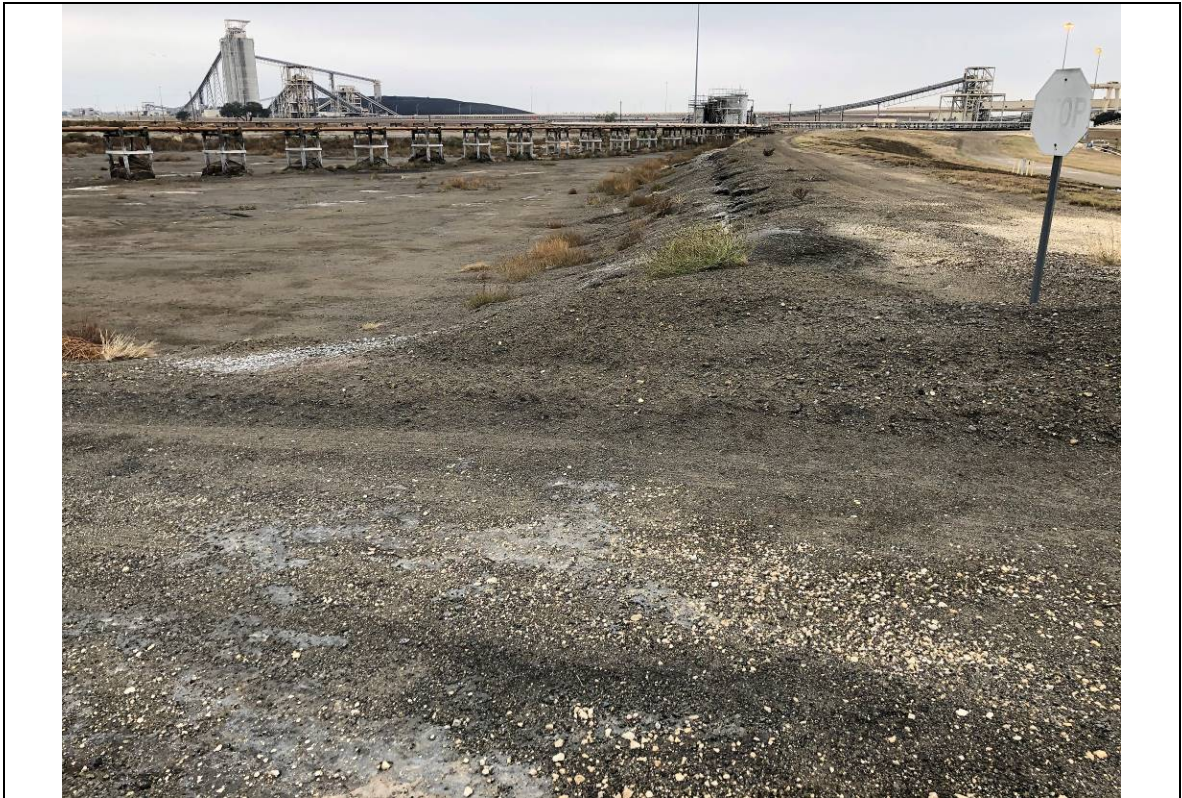
**Photograph: 18** North Bottom Ash Pond – standing on northwest corner – facing southwest. Photo taken 12/15/2020.

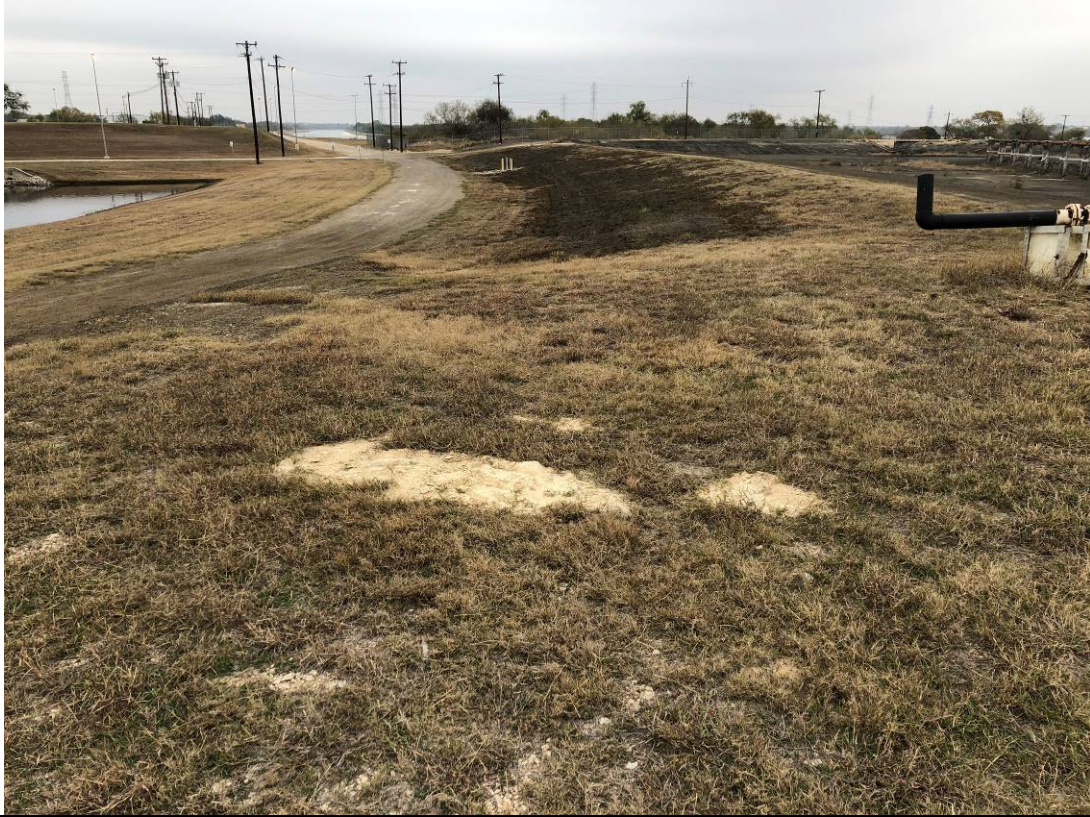
**Photograph: 19** North Bottom Ash Pond – standing on southwest corner – facing northeast.  
Photo taken 12/15/2020.

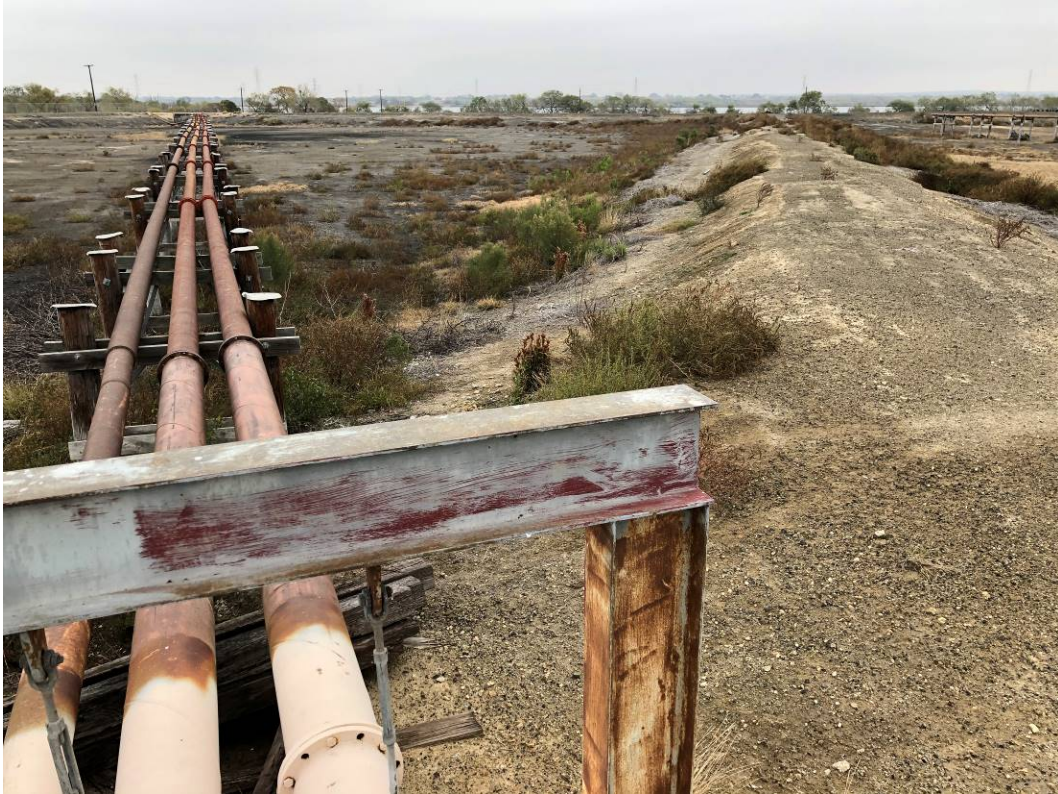
**Photograph: 20** North Bottom Ash Pond – standing on southwest corner – facing east.  
Photo taken 12/15/2020.

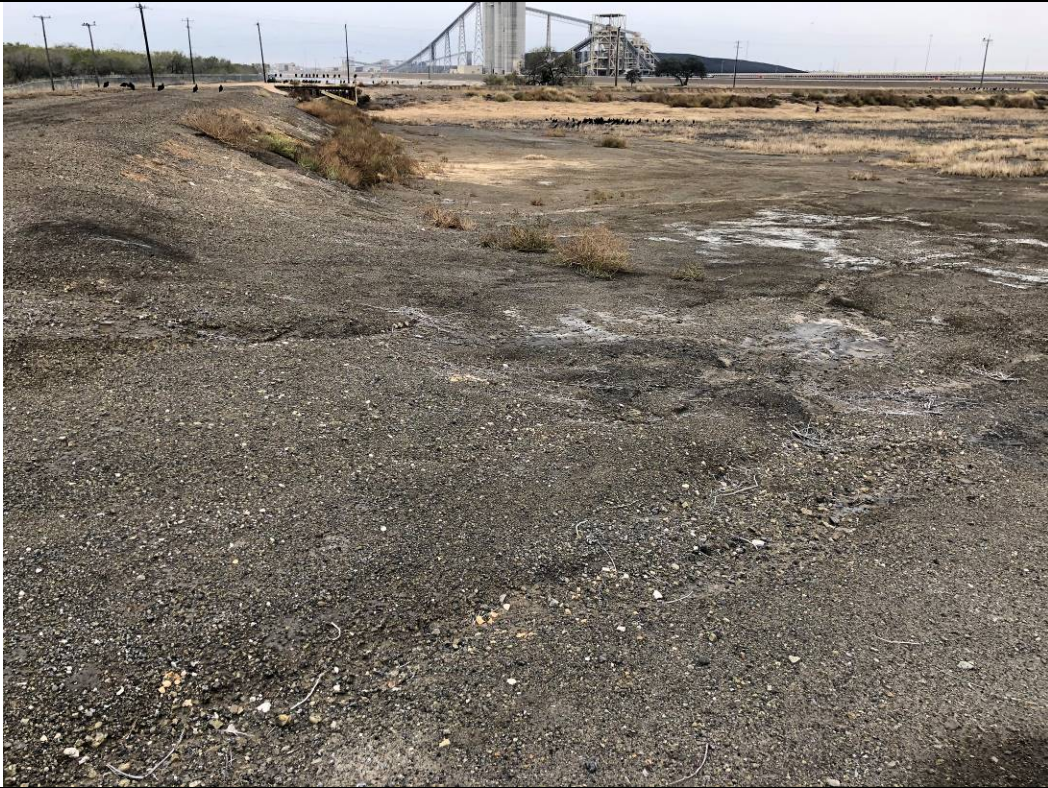
**Photograph: 21** South Bottom Ash Pond – standing on northeast corner – facing south.  
Photo taken 12/15/2020.

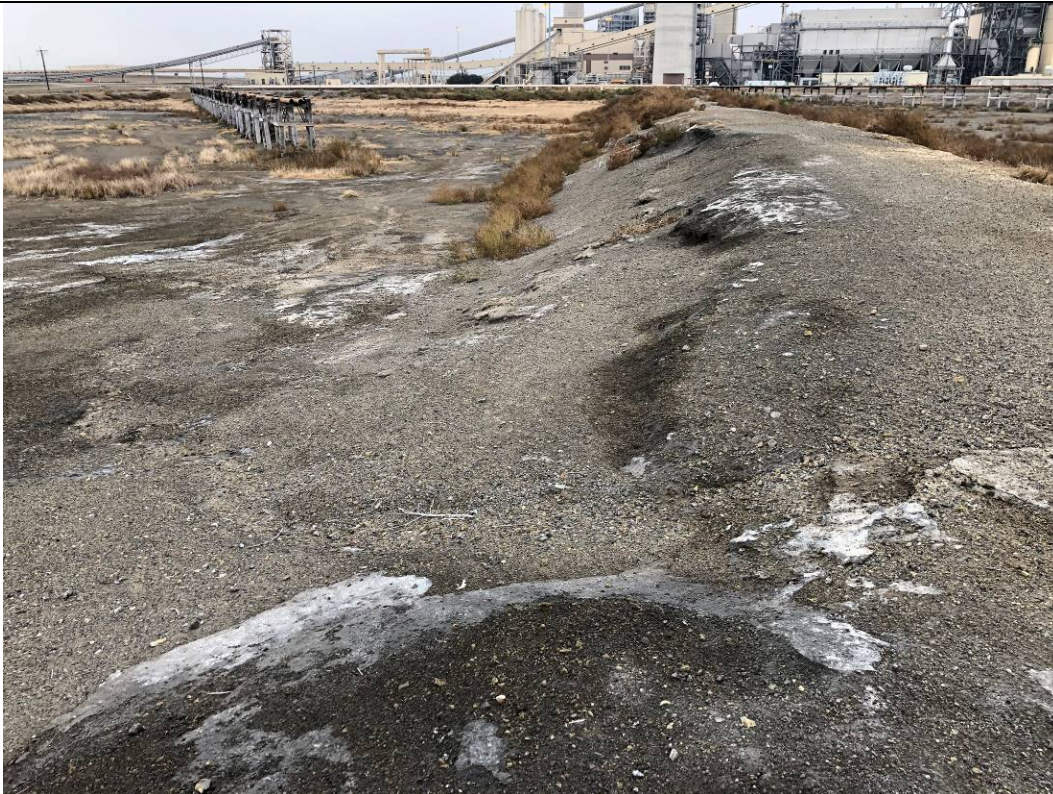
**Photograph: 22** South Bottom Ash Pond – standing on northeast corner – facing west.  
Photo taken 12/15/2020.

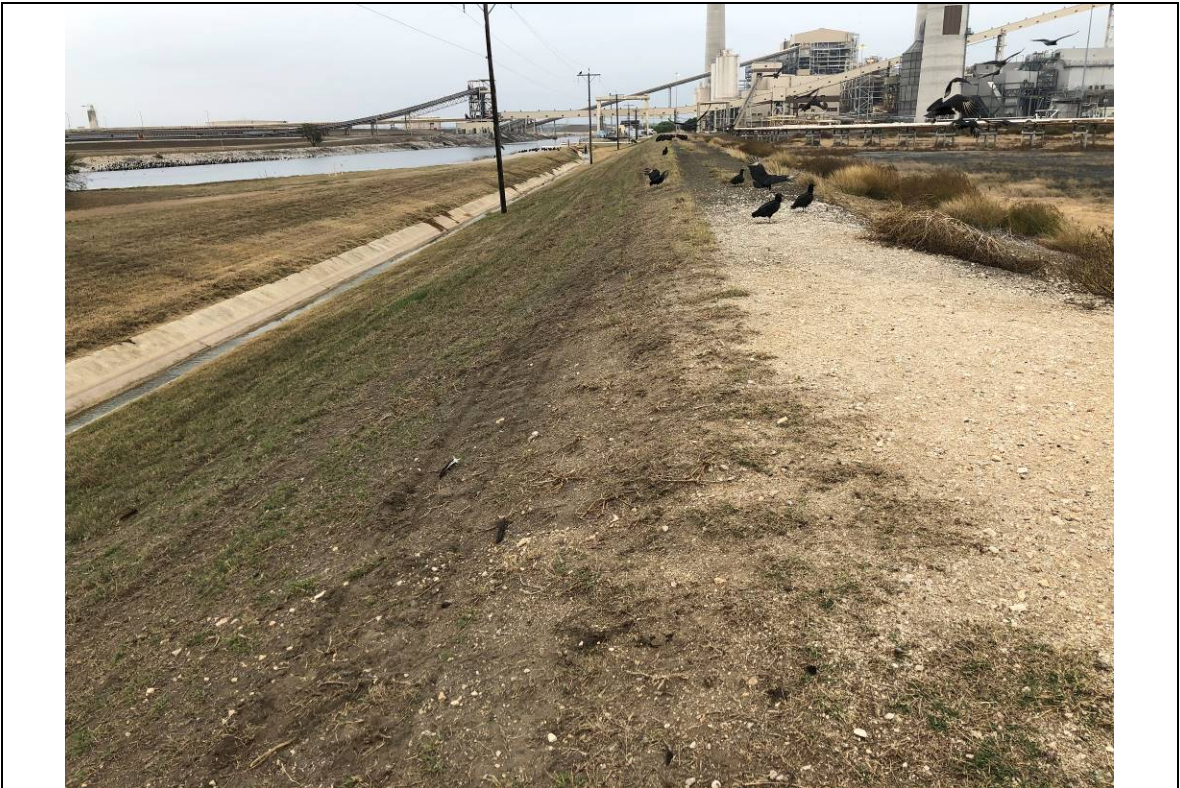
**Photograph: 23** South Bottom Ash Pond – standing on southeast corner – facing west. Photo taken 12/15/2020.

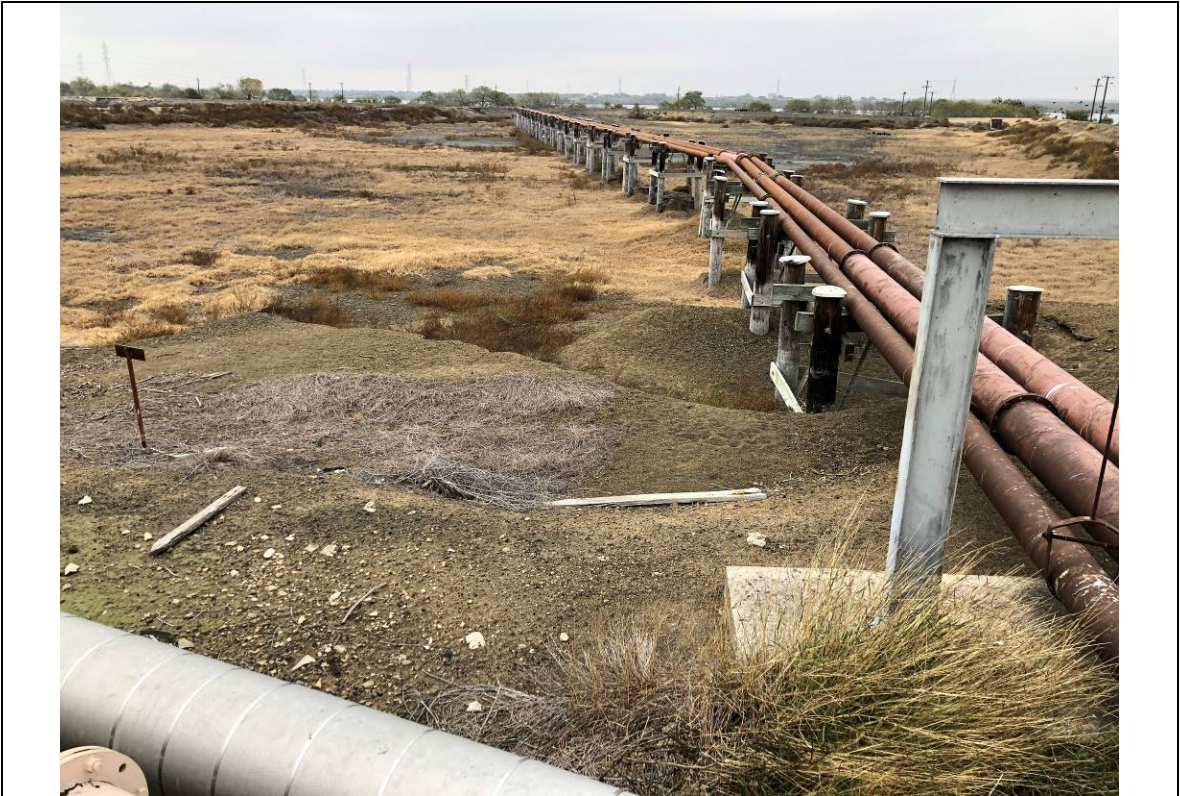
**Photograph: 24** South Bottom Ash Pond – standing on southwest corner – facing northeast. Photo taken 12/15/2020.

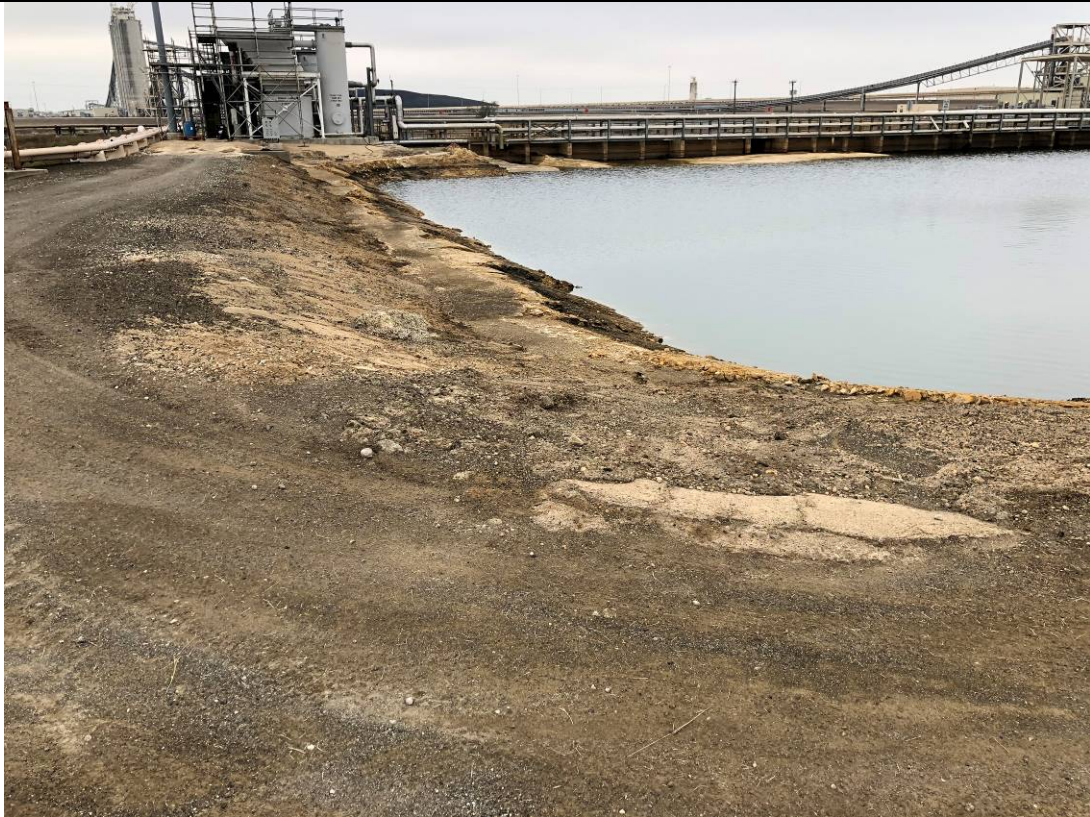
**Photograph: 25** North SRH Pond – standing on northeast corner – facing south. Photo taken 12/15/2020.
