Project No. 0352436

Subject: CCR Units – 2020 Annual Inspection and Fugitive Dust  
Control Report  
Calaveras Power Station  
San Antonio, Texas

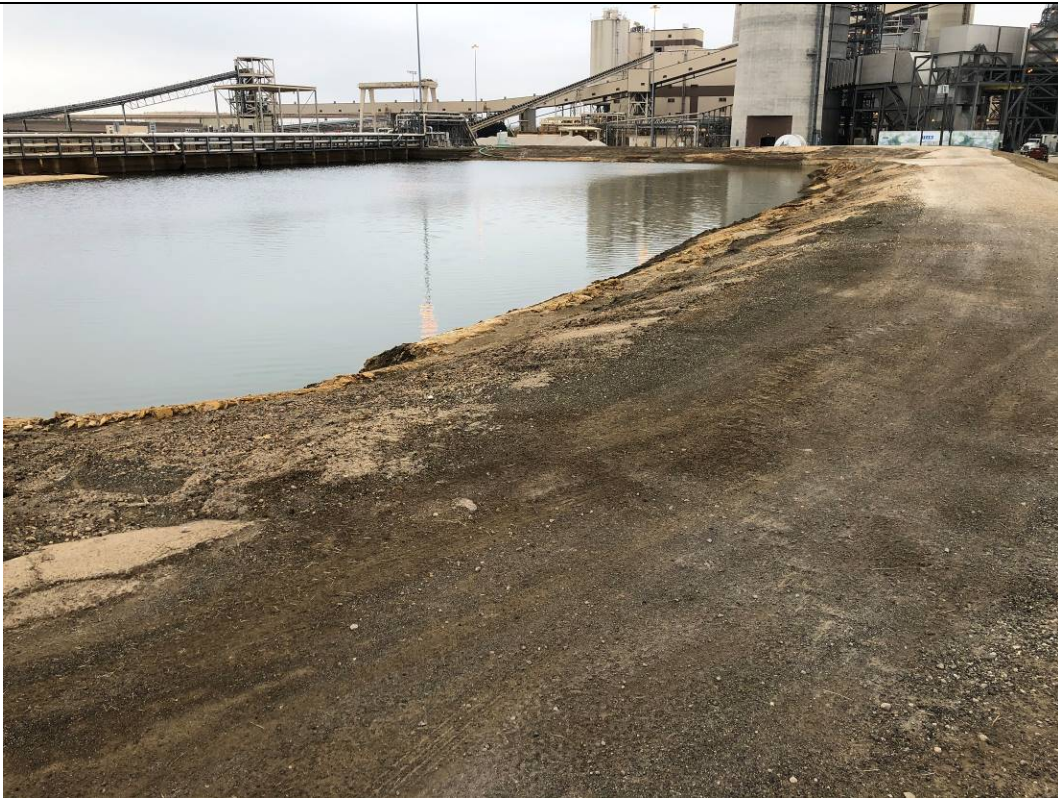
**Photograph: 26** North SRH Pond – standing on northeast corner – facing west. Photo taken 12/15/2020.

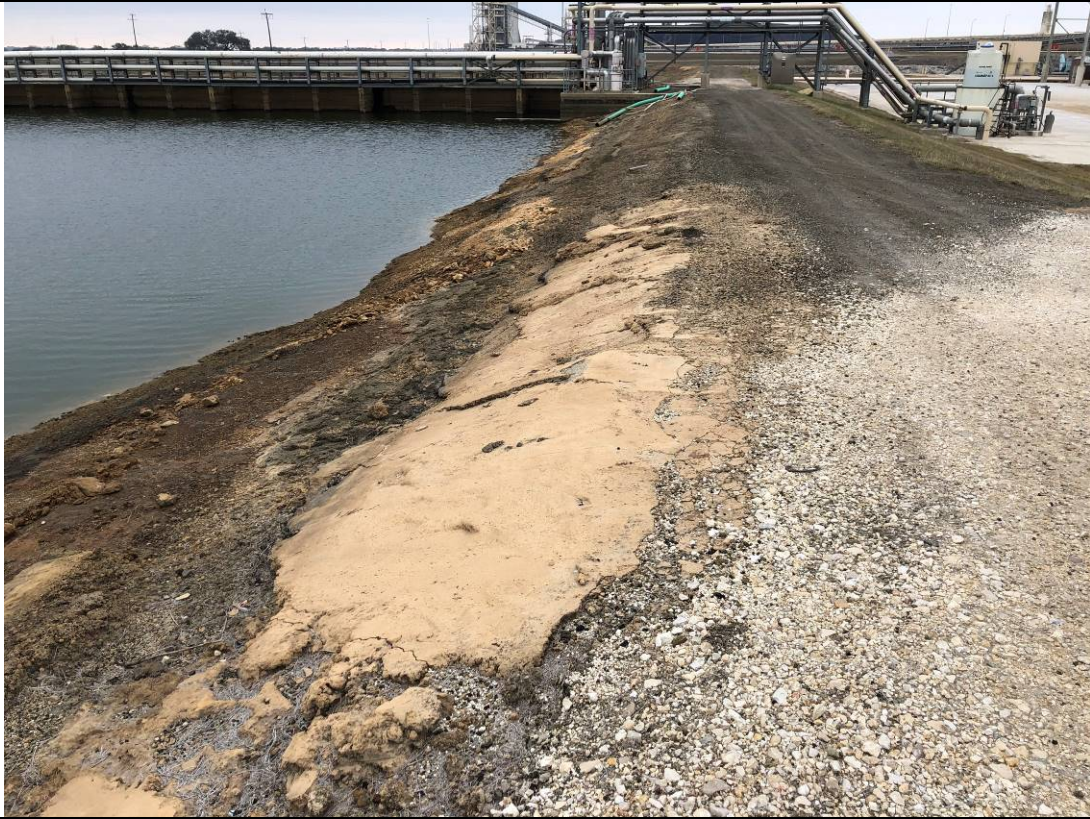
**Photograph: 27** | North SRH Pond – standing on northwest corner – facing south. Photo taken 12/15/2020.

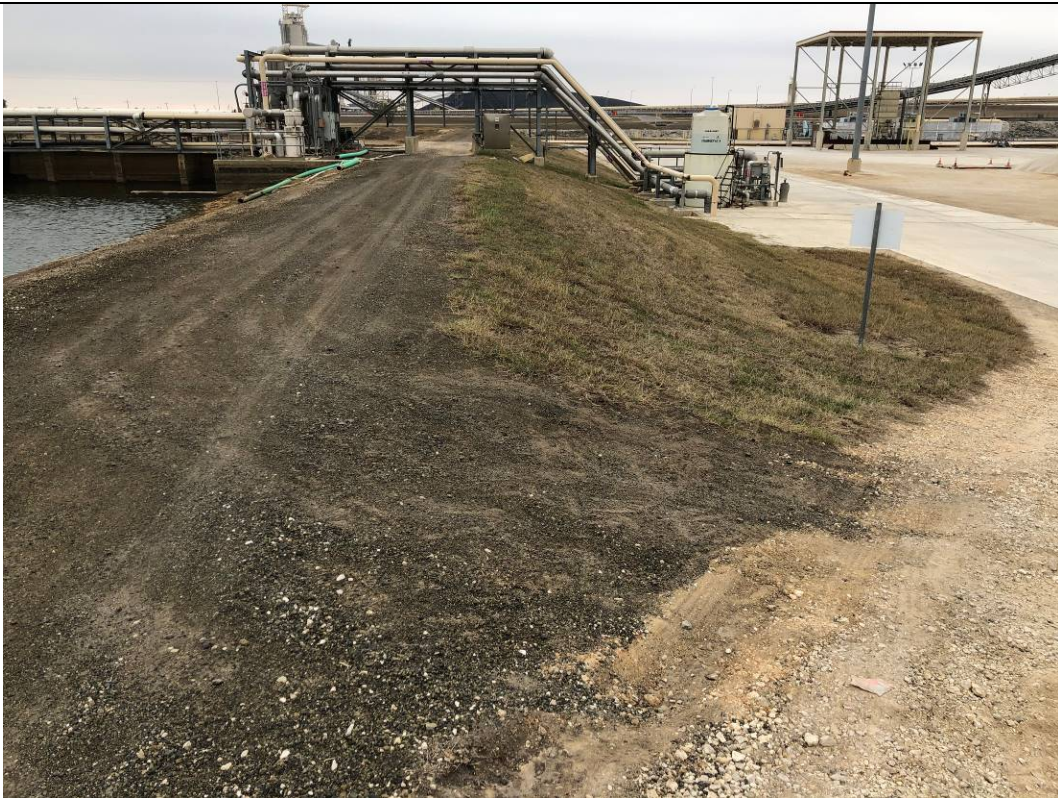
**Photograph: 28** | North SRH Pond – standing on northwest corner – facing south. Photo taken 12/15/2020.

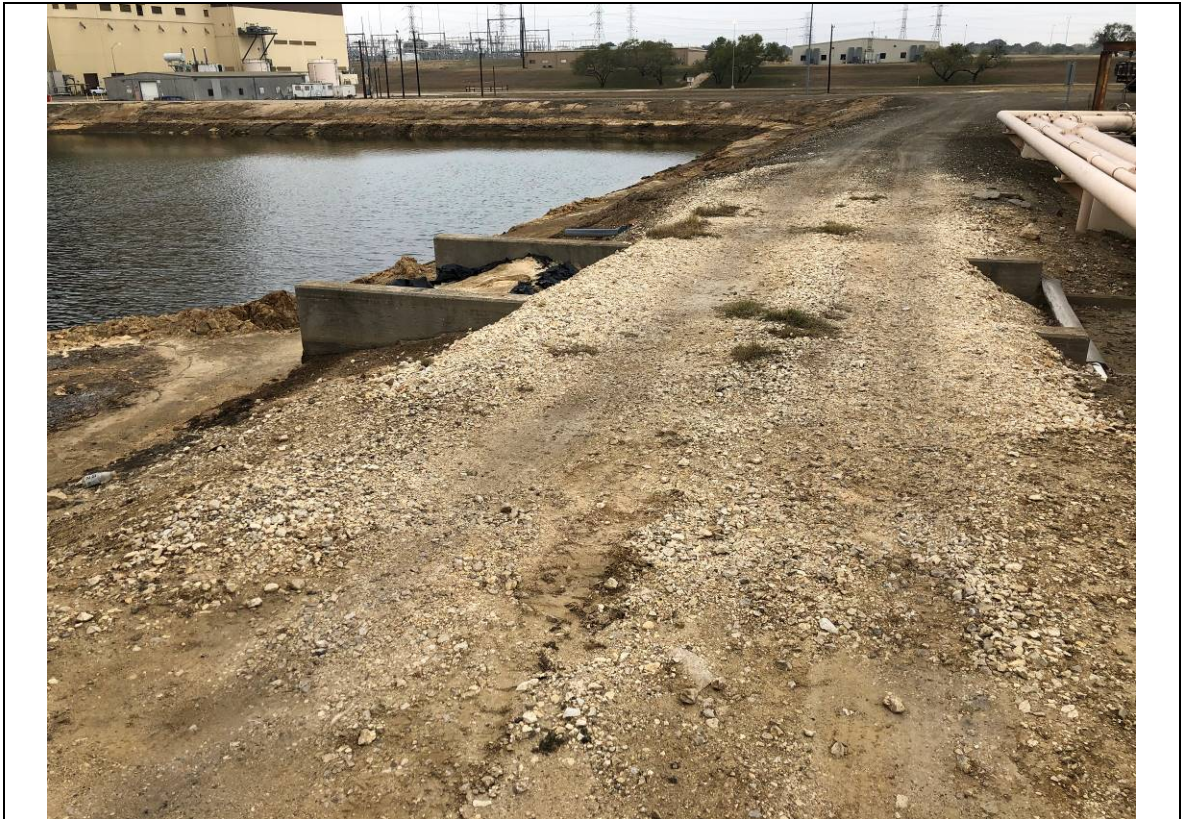
**Photograph: 29** North SRH Pond – standing on southeast corner – facing north. Spillway structure. Photo taken 12/15/2020.

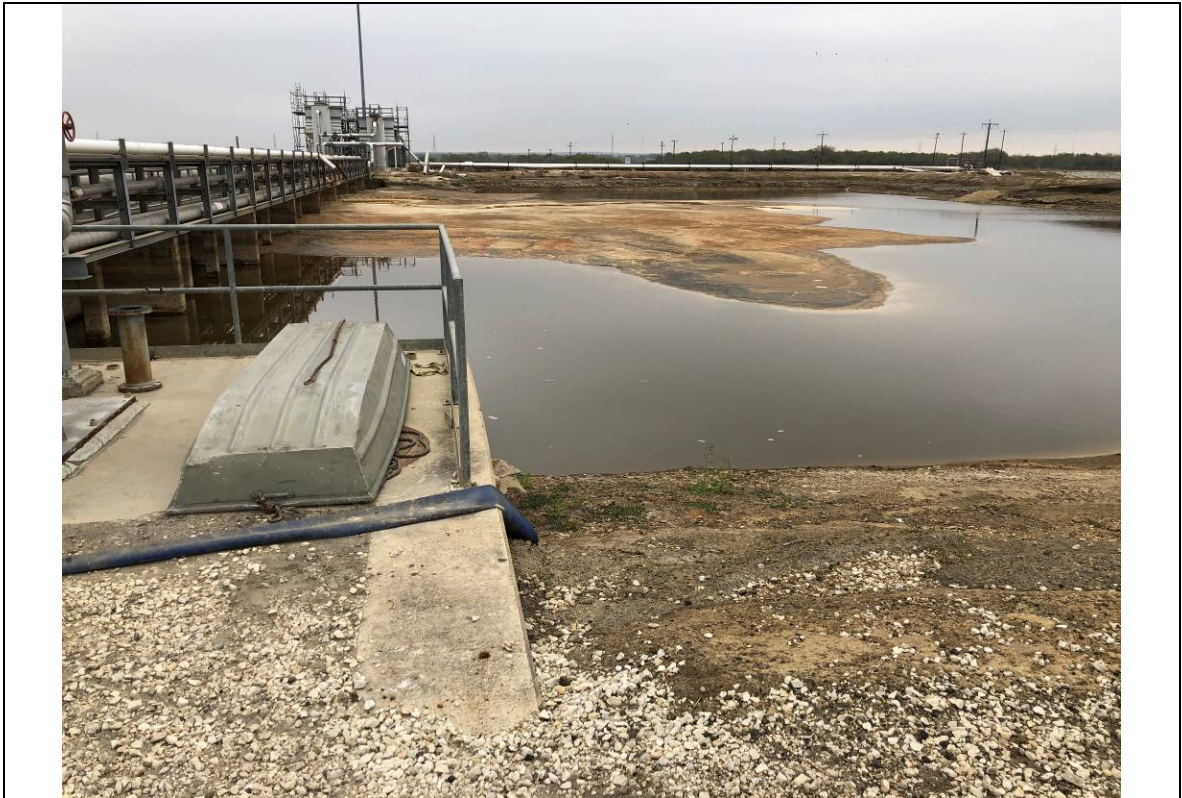
**Photograph: 30** South SRH Pond – standing on the northwest corner – facing east. Photo taken 12/15/2020.

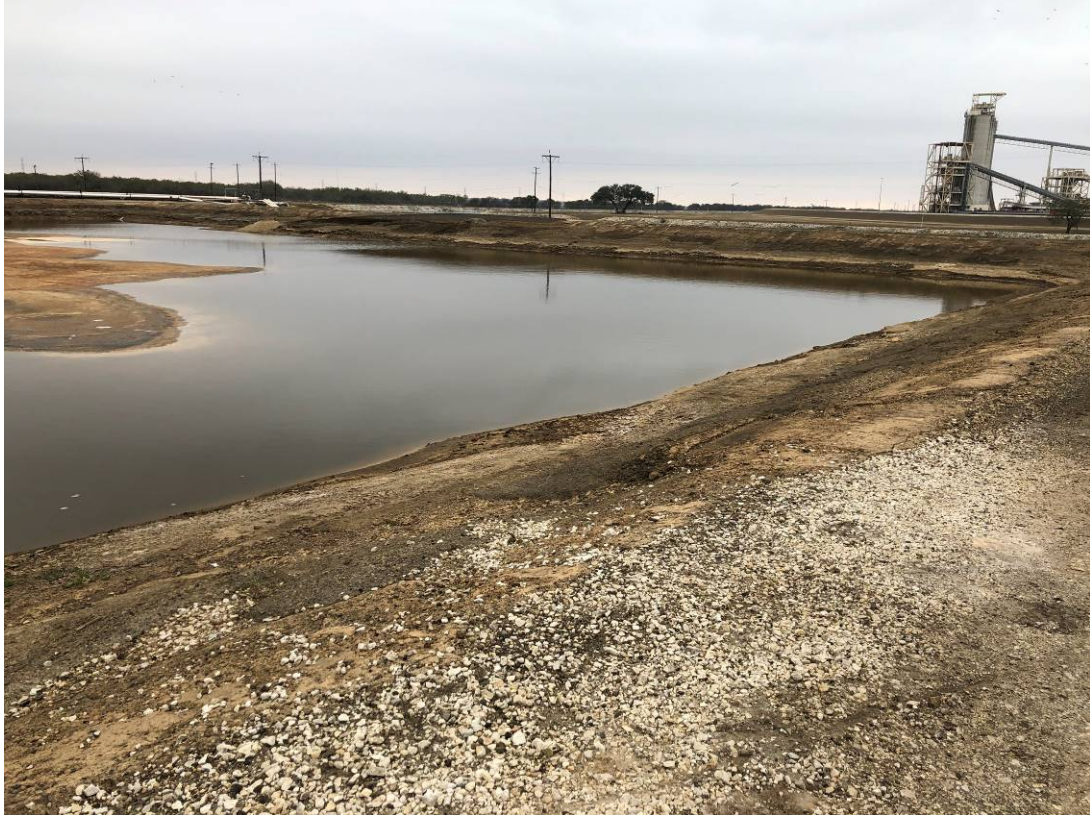
**Photograph: 31** | South SRH Pond – standing on the northwest corner – facing southeast. Photo taken 12/15/2020.

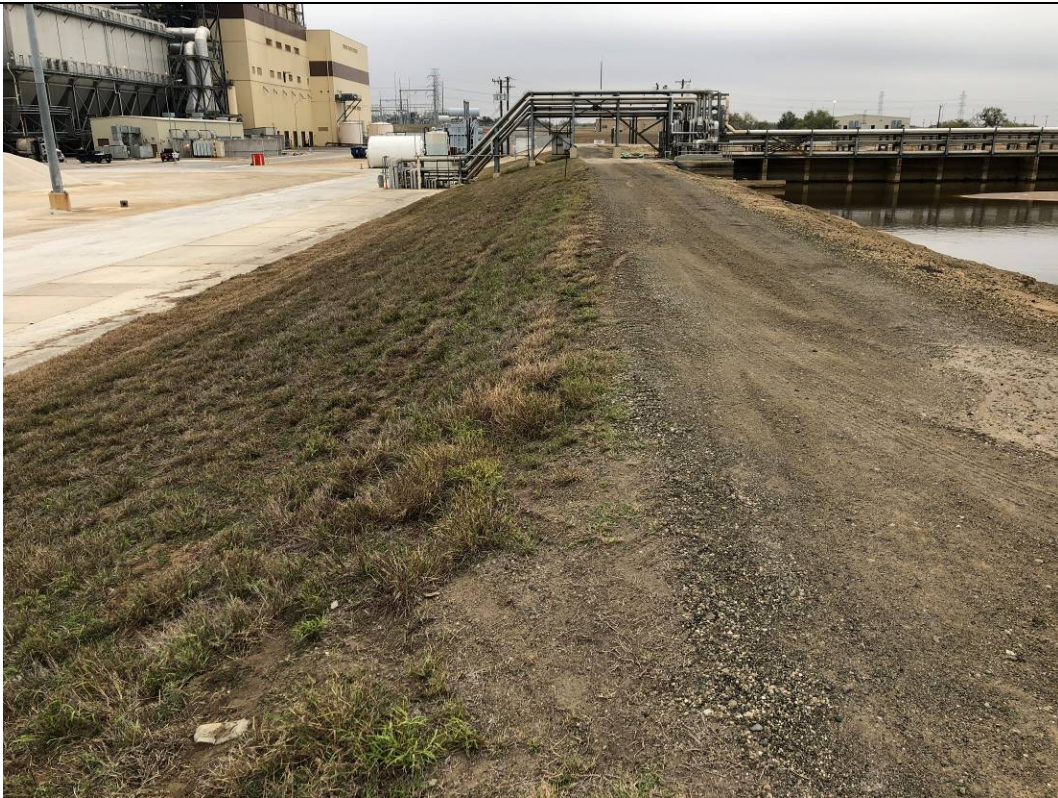
**Photograph: 32** | South SRH Pond – standing on the southwest corner – facing north. Photo taken 12/15/2020.

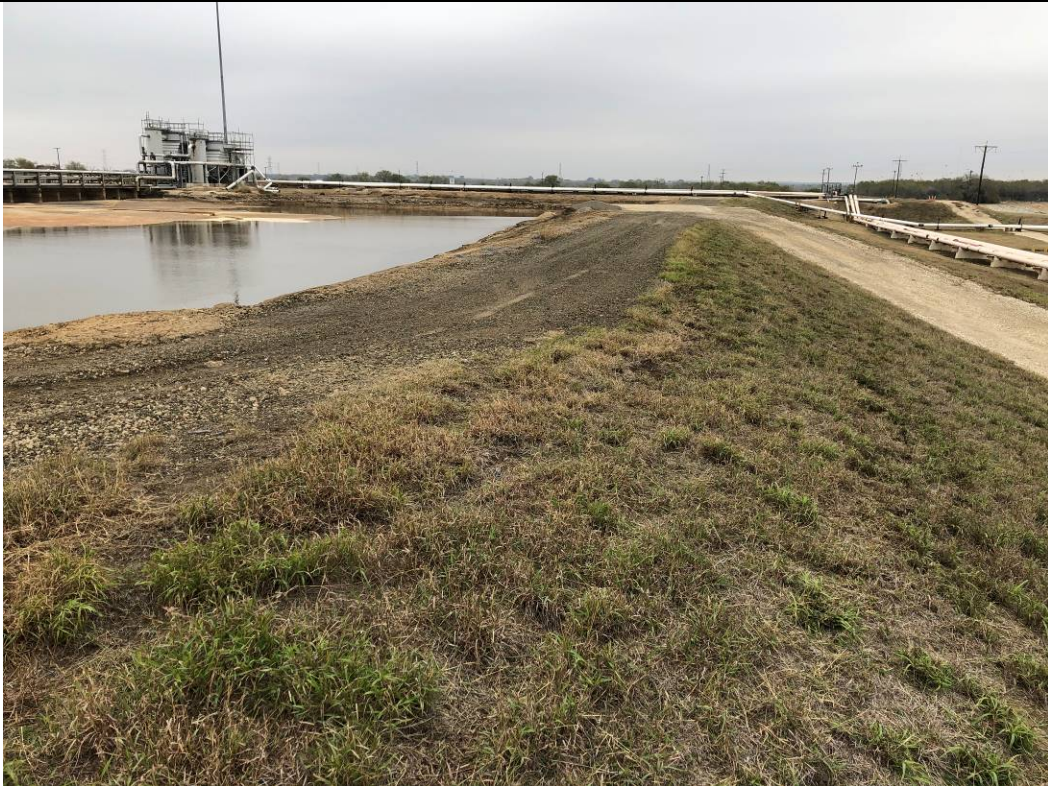
**Photograph: 33** South SRH Pond – standing on the southwest corner – facing east. Photo taken 12/15/2020.

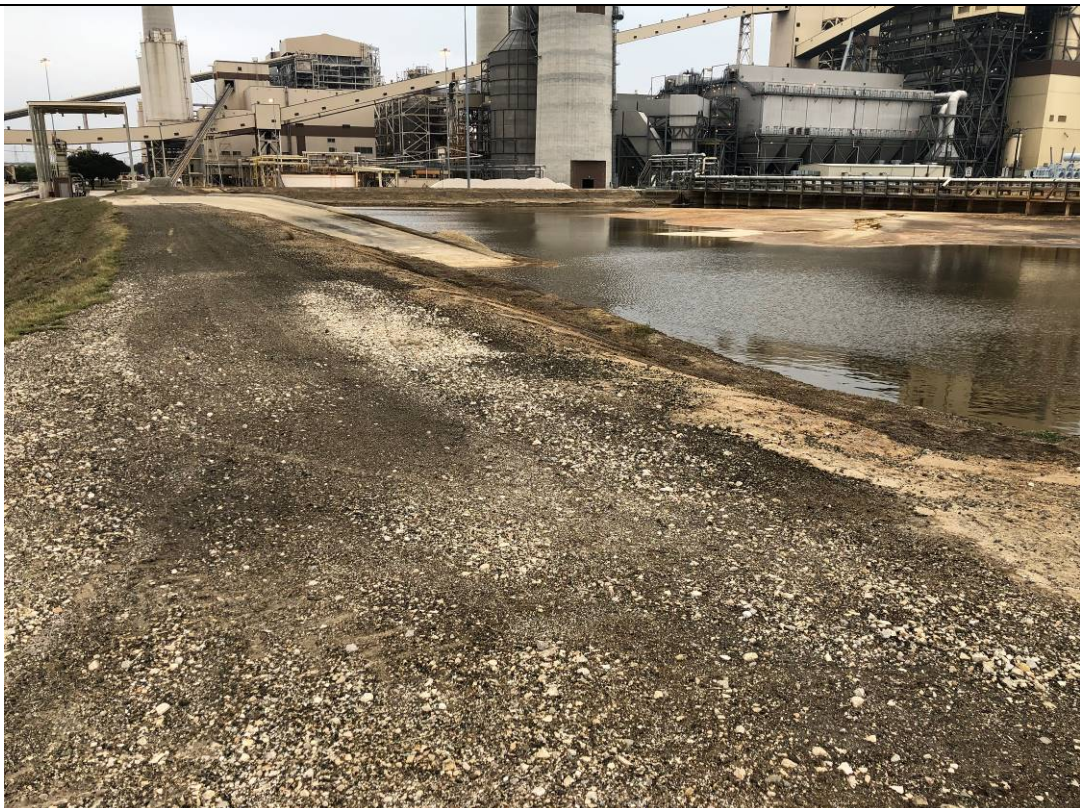
**Photograph: 34** South SRH Pond – standing on the southeast corner – facing west. Photo taken 12/15/2020.

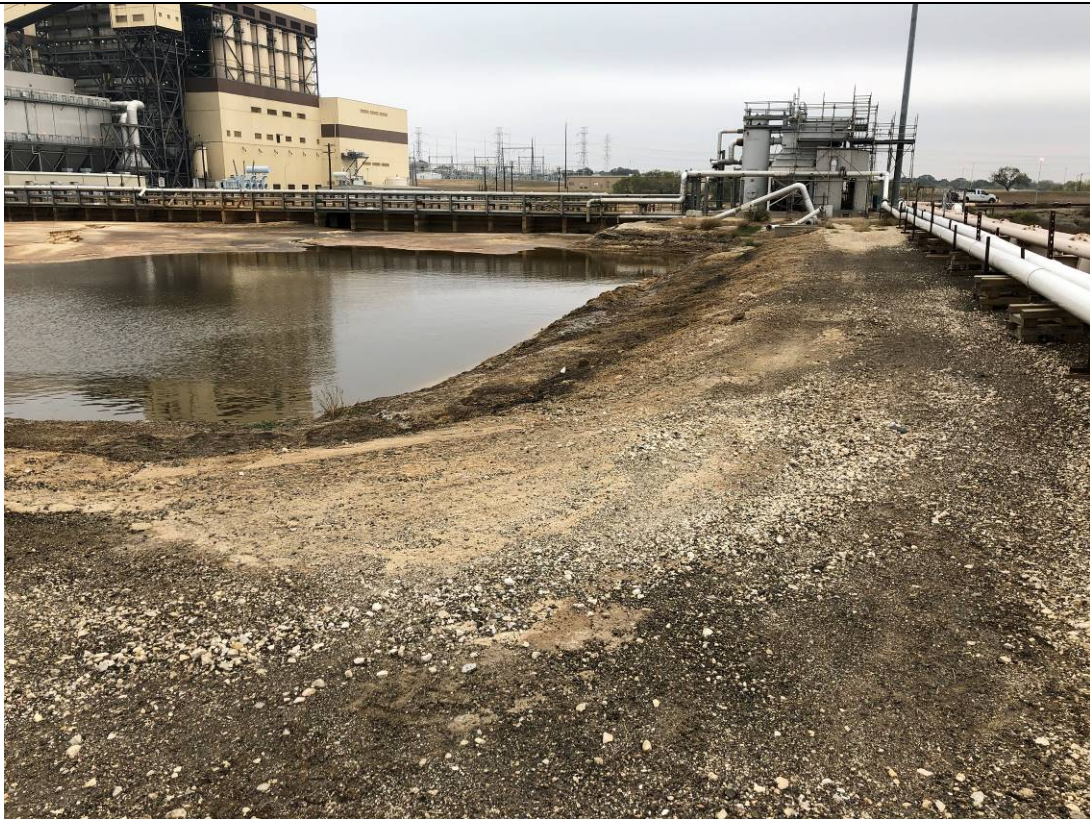
**Photograph: 35** South SRH Pond – standing on northwest corner – facing south. Photo taken 12/15/2020.

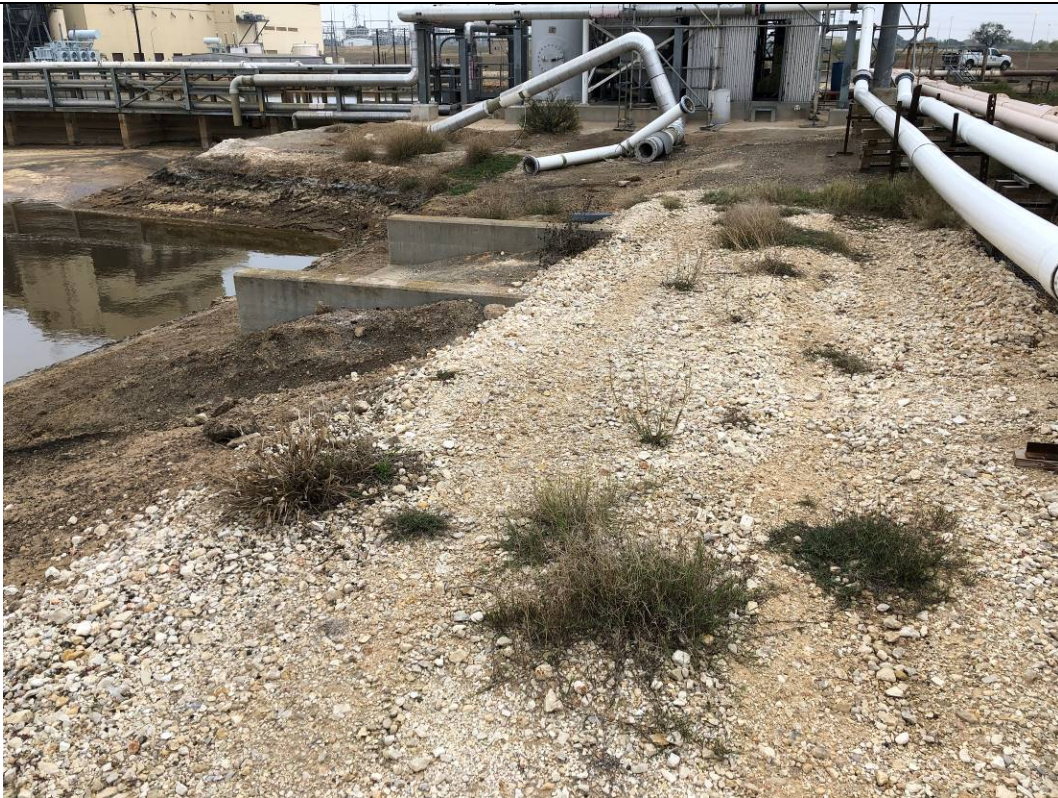
**Photograph: 36** South SRH Pond – standing on east corner – facing north. Spillway structure. Photo taken 12/15/2020.
