Alternative Capacity Infeasibility Demonstration

Evaporation Pond
CPS Energy Calaveras Power Station
Bexar County, Texas

30 November 2020

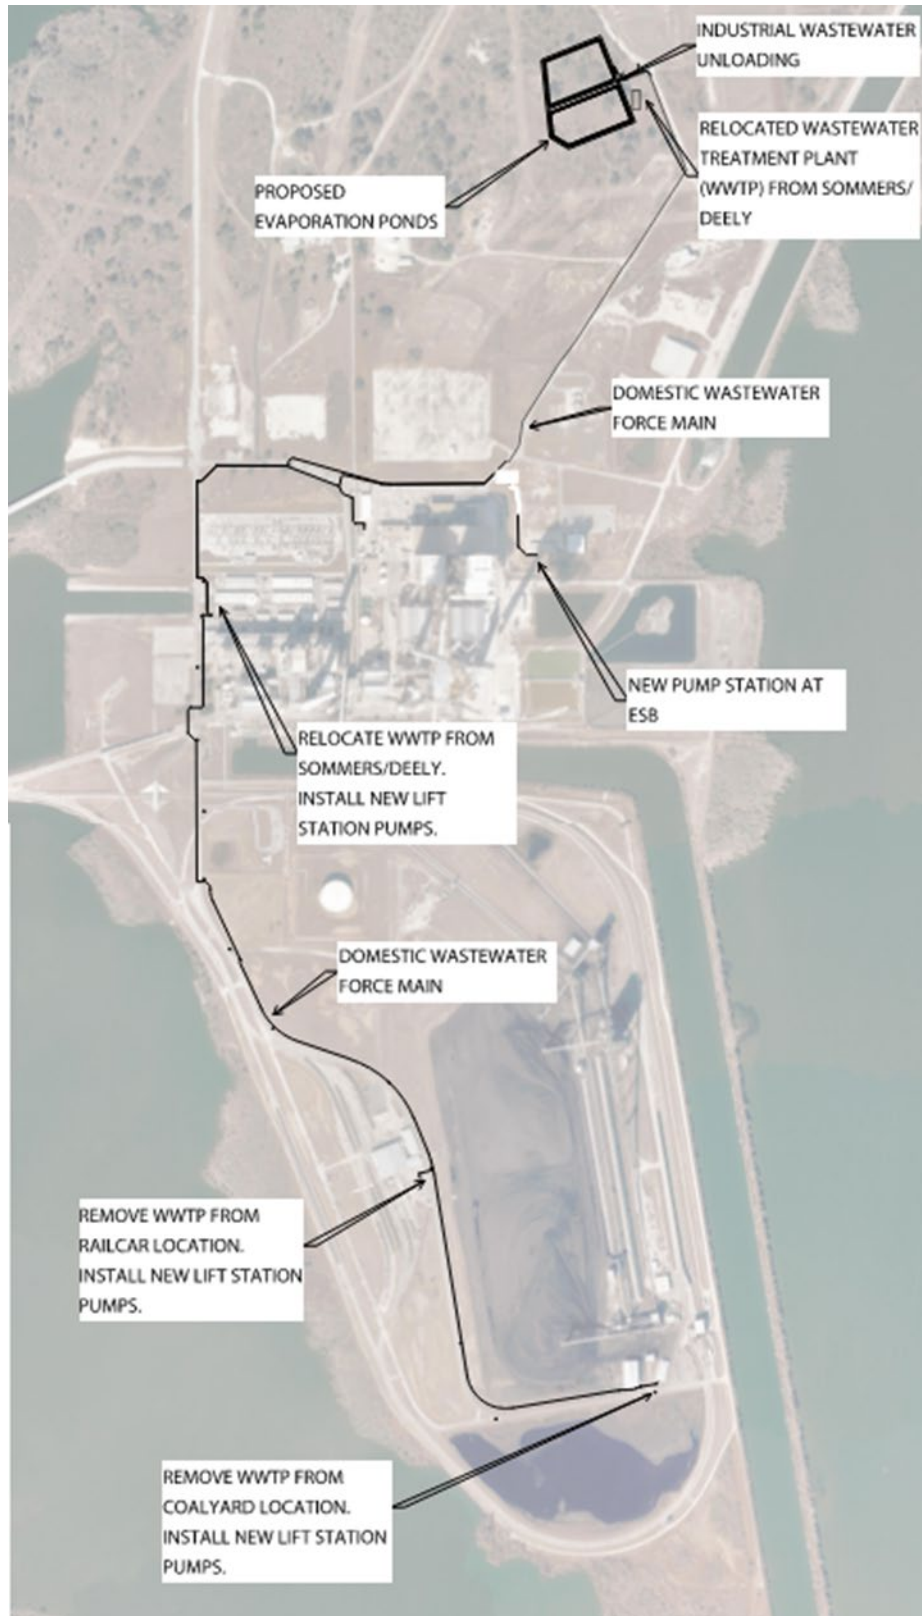
Exhibit 3.4: Proposed Site Plan

Based on the work completed to date, CPS Energy identified the following primary scope items for construction of the new EP:

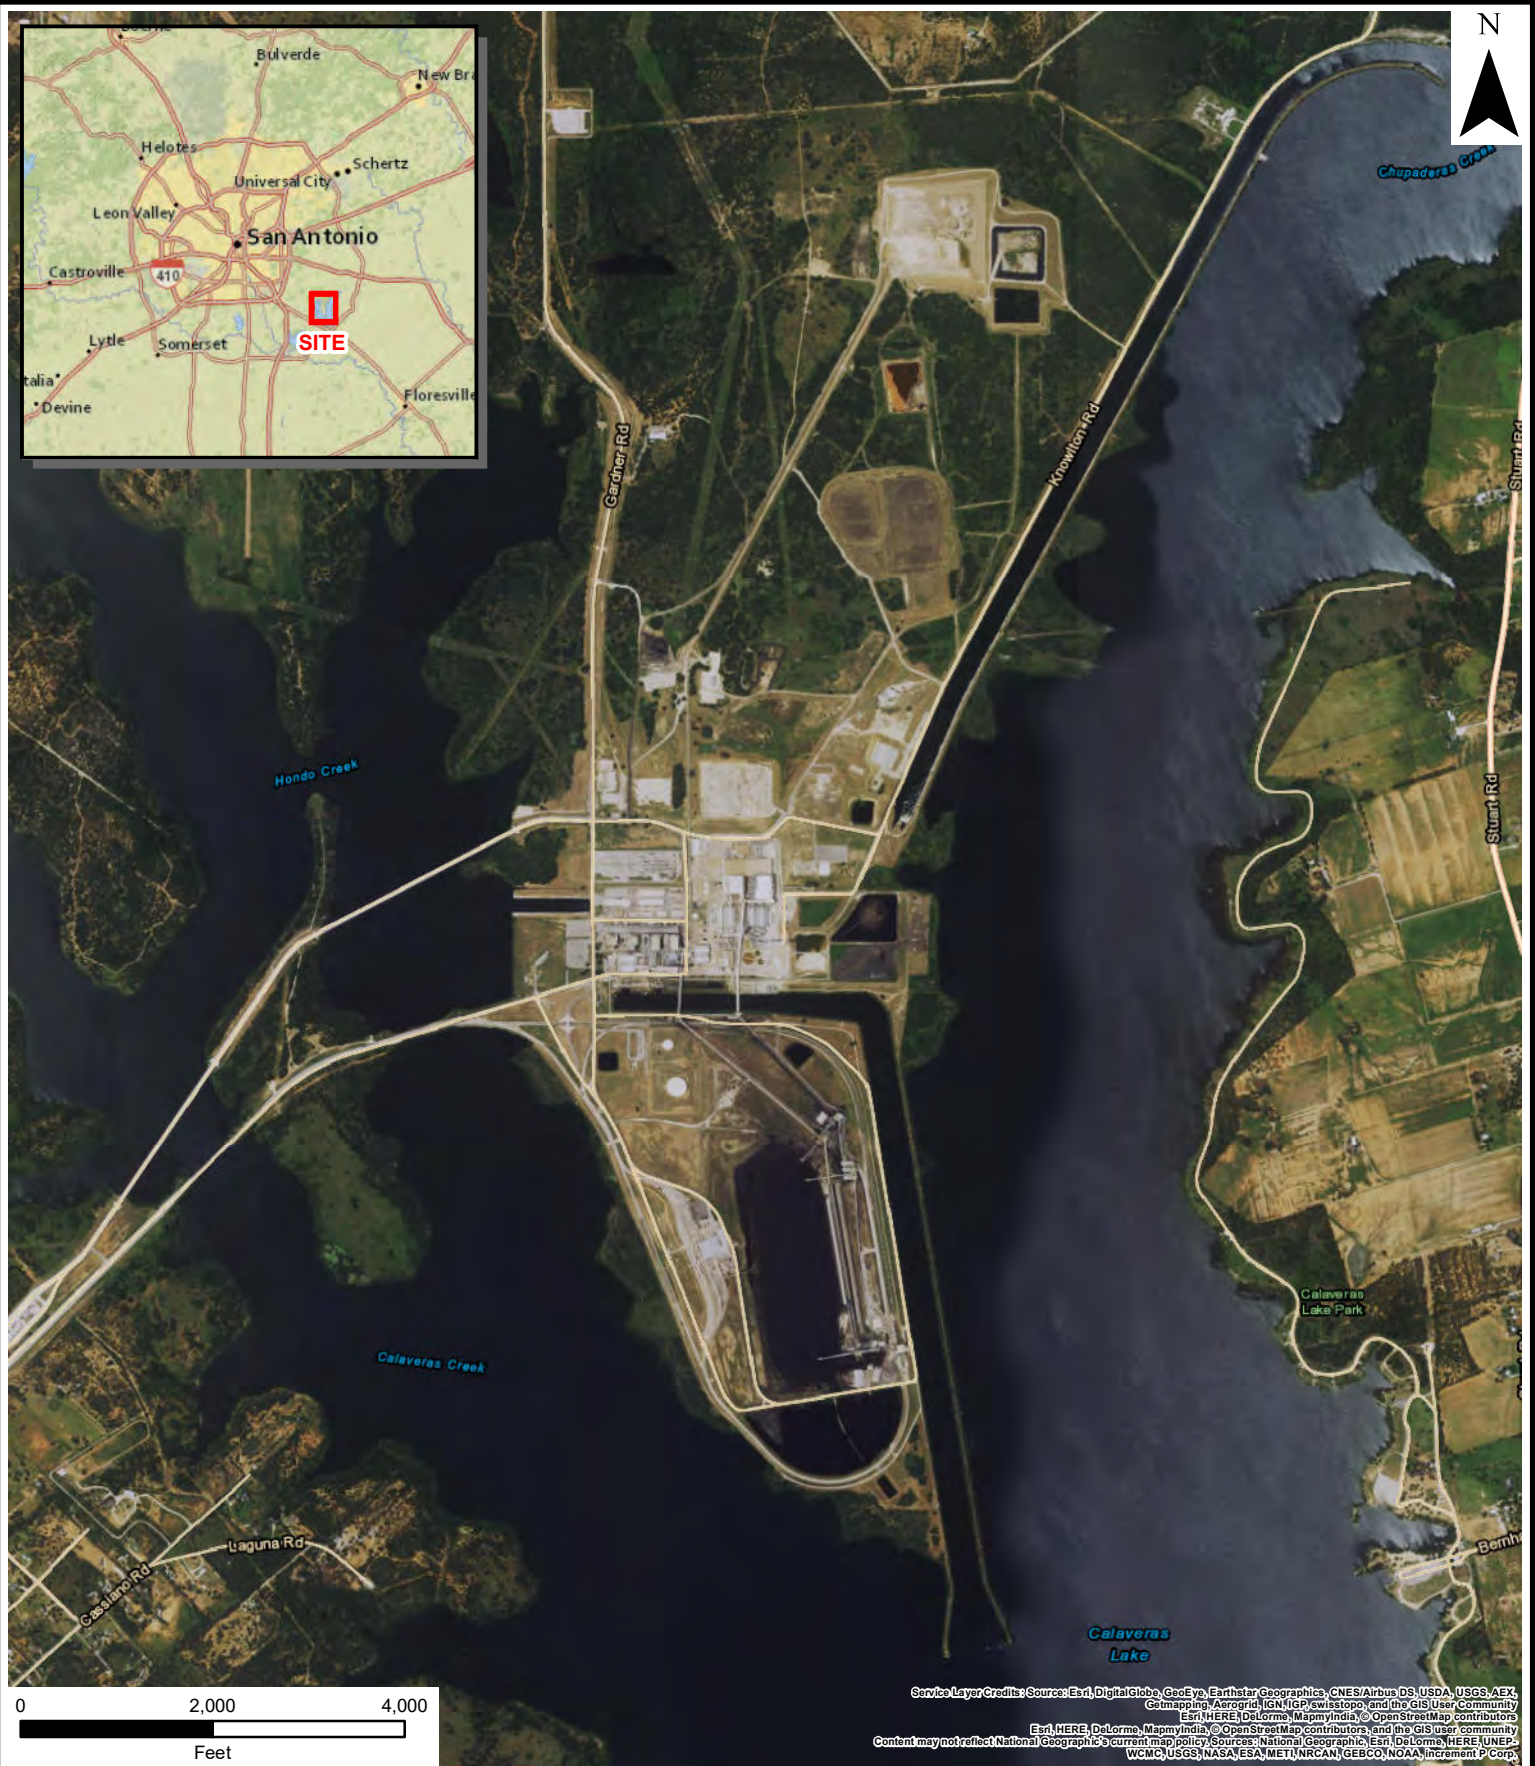
FIGURE 2.1
FACILITY LOCATION MAP

CPS Energy owns and operates the Calaveras Power Station located at 12940 U.S. Highway 181 South in San Antonio, Texas. A Facility Location Map is provided as Figure 2.1. The Calaveras Power Station consists of three power plants of which two plants (J.T. Deely and J.K. Spruce) are subject to regulation under the CCR Rule. Specifically, CPS Energy operates three CCR units at the Calaveras Power Station: EP, Fly Ash Landfill, and the Sludge Recycle Holding Pond. Although the J.T. Deely Power Plant ceased operation at the end of December 2018, and sluiced bottom ash is no longer being received at the Bottom Ash Ponds (BAPs), the BAPs will continue to be monitored until the units have undergone closure. A CCR Unit Location Map is provided as Figure 2.2.

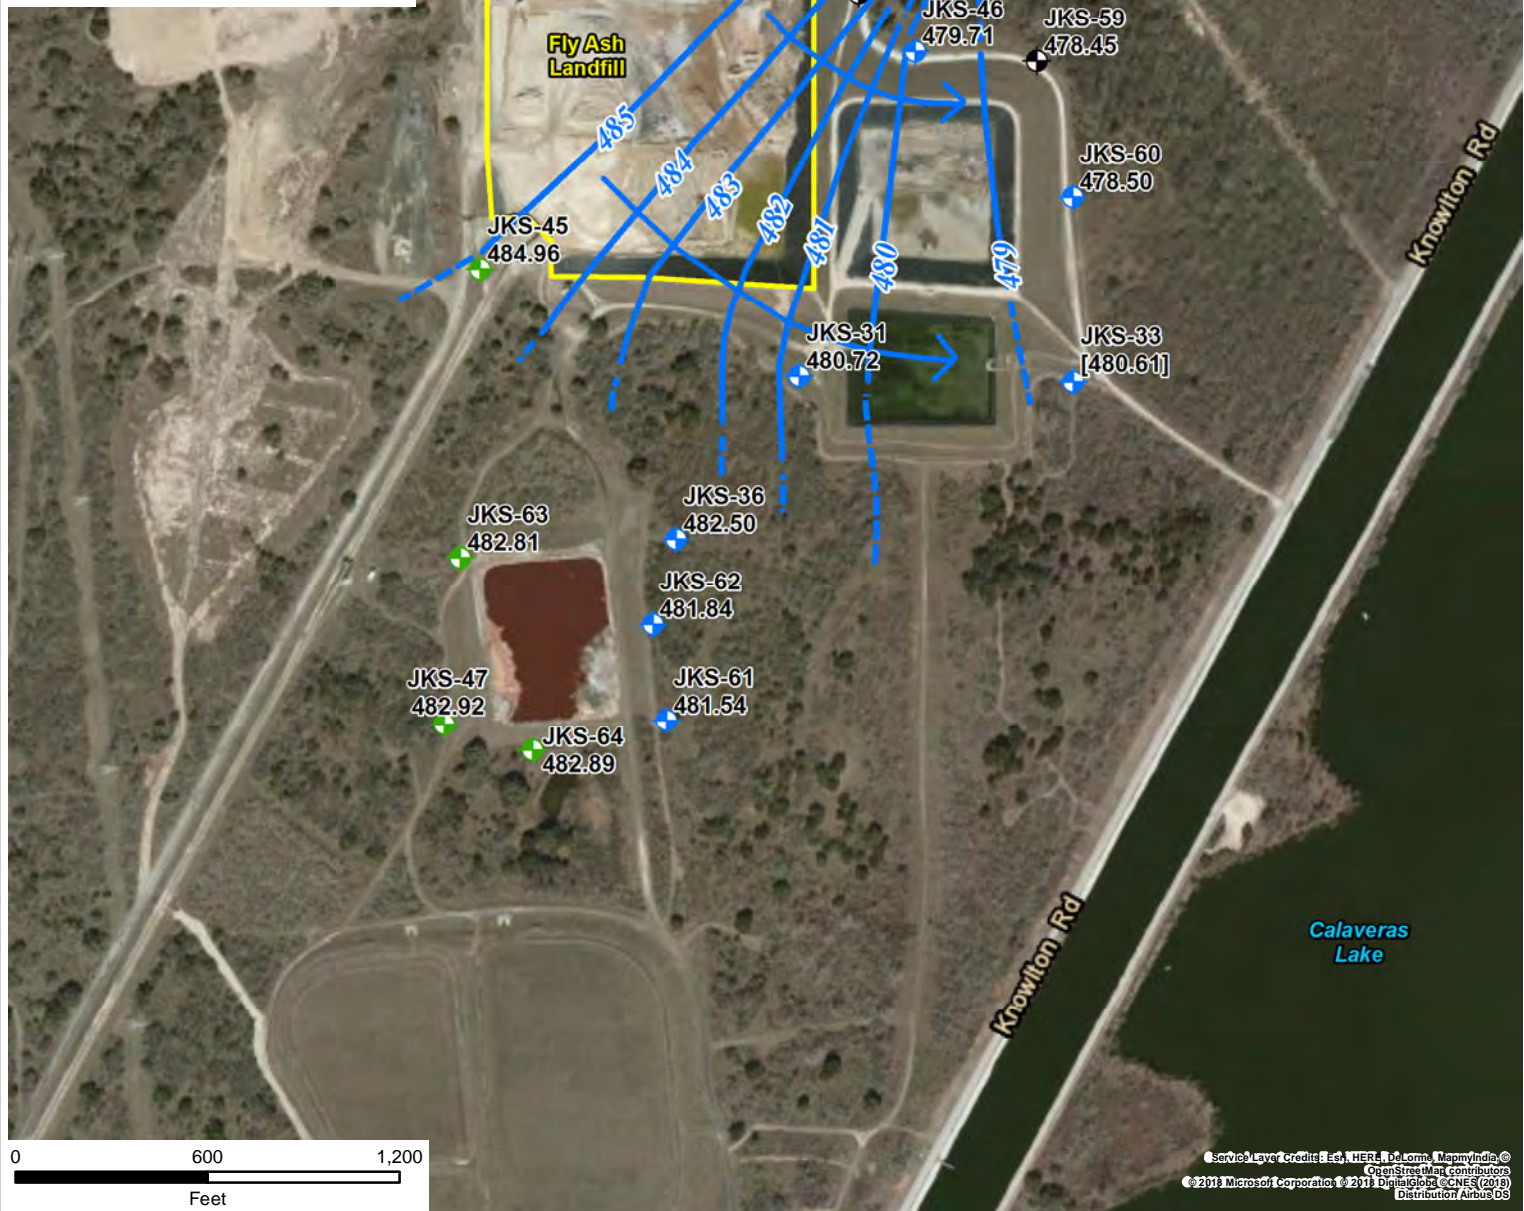
POTENTIOMETRIC SURFACE MAP -
 OCTOBER 2017
 Fly Ash Landfill CCR Unit
 CPS Energy - Calaveras Power Station
 San Antonio, Texas

Groundwater Flow Direction
- 484.96 Potentiometric Surface Elevation (Feet, Mean Sea Level)
- [480.61] Elevations in brackets were not utilized to contour potentiometric surface

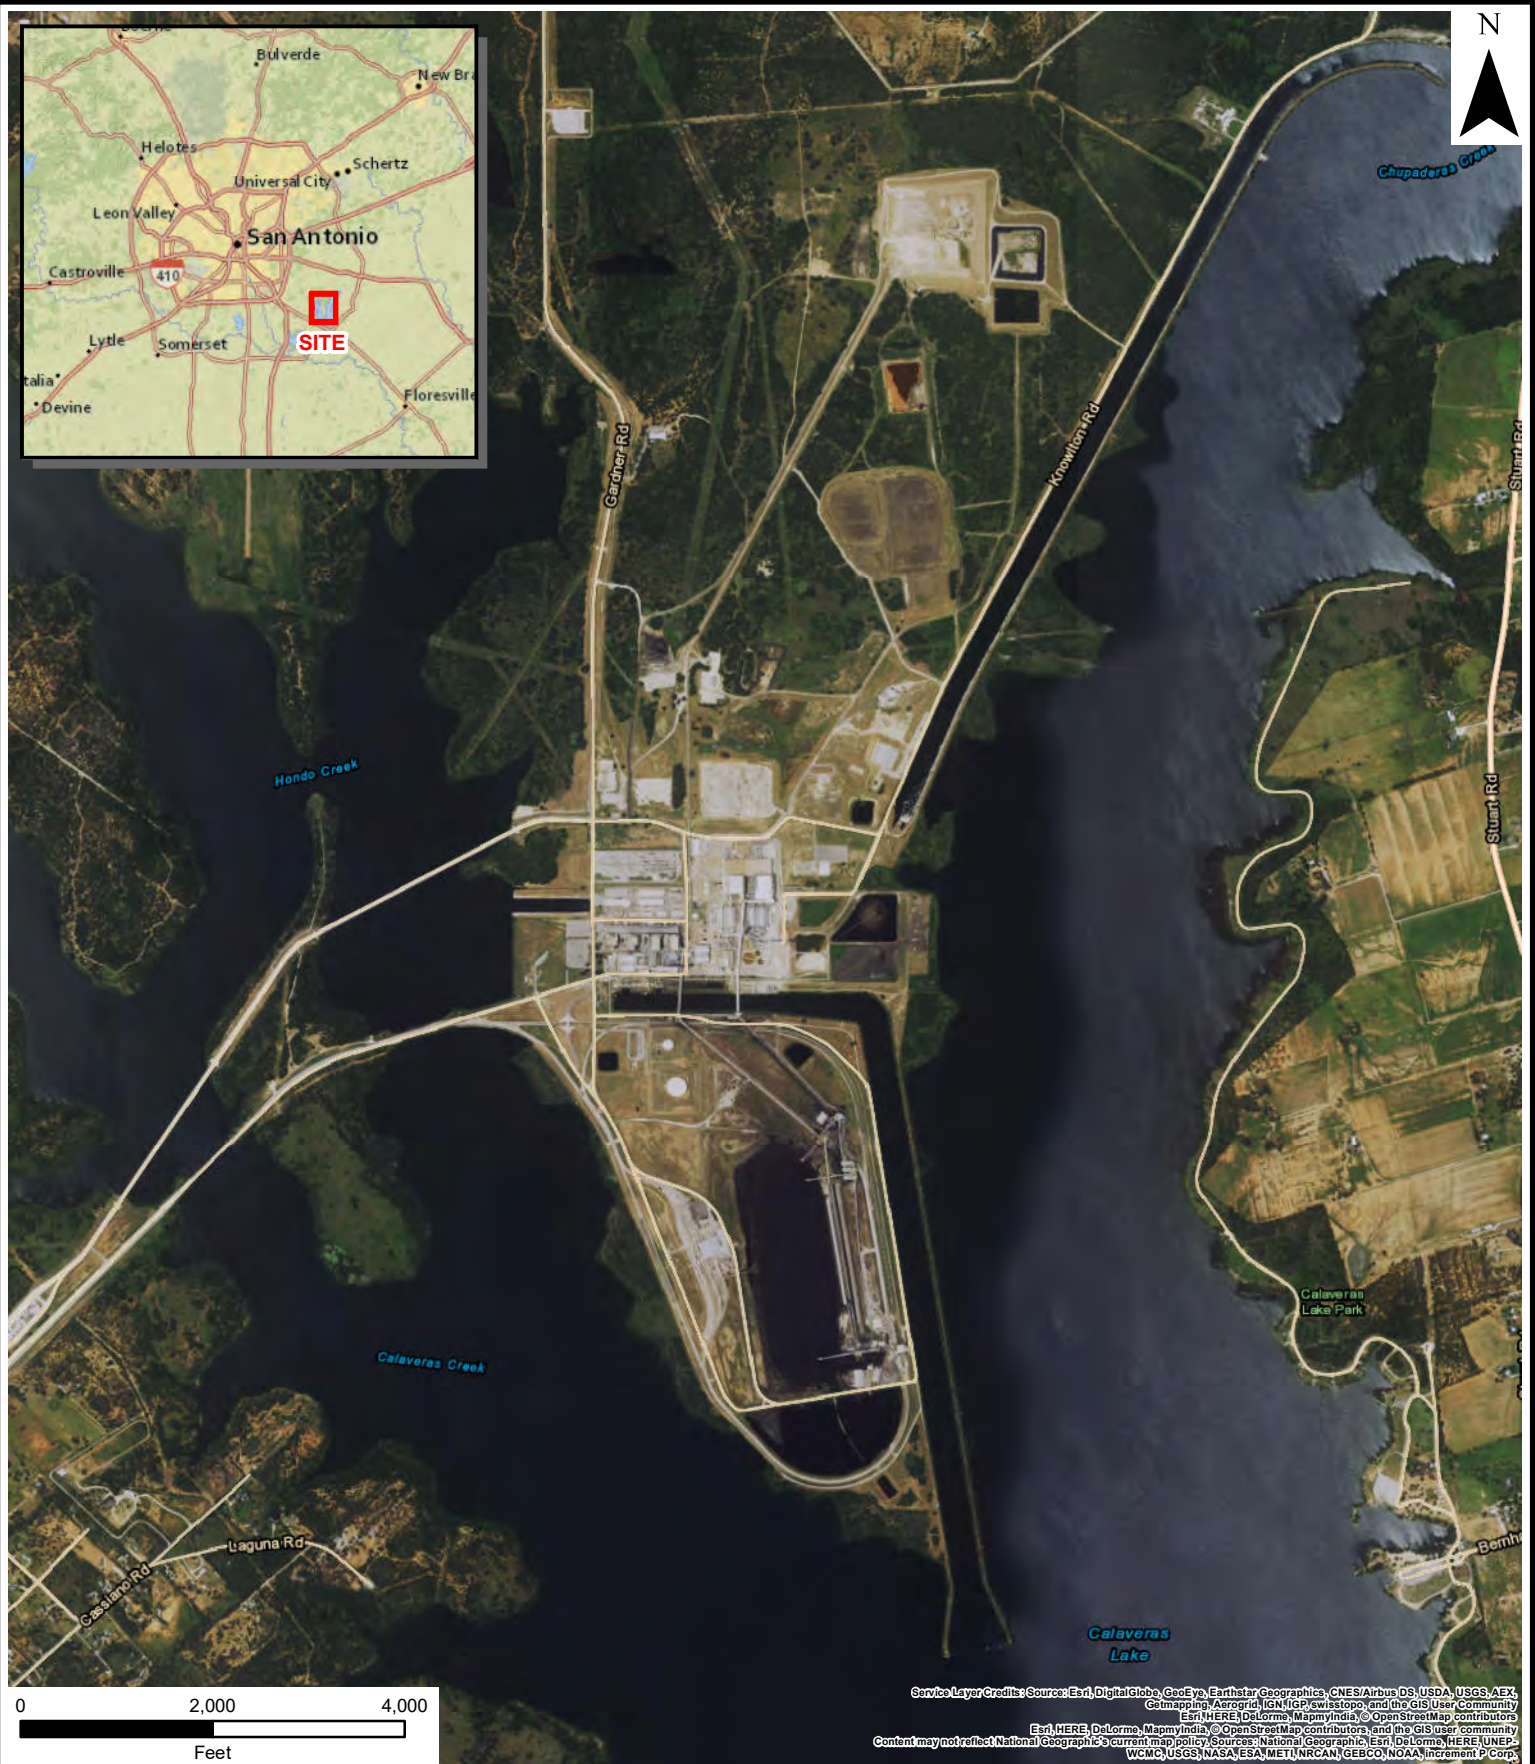
FIGURE 1
 GENERAL SITE LOCATION MAP
 CPS Energy - Calaveras Power Station
 San Antonio, Texas

CPS Energy owns and operates the Calaveras Power Station located southeast of San Antonio in Bexar County, Texas. Within this power station, there are two coal-fired plants (J.T. Deely Power Plant and J.K. Spruce Power Plant) that generate CCR that are subject to the CCR Rule. A General Site Location Map is provided as **Figure 1**.

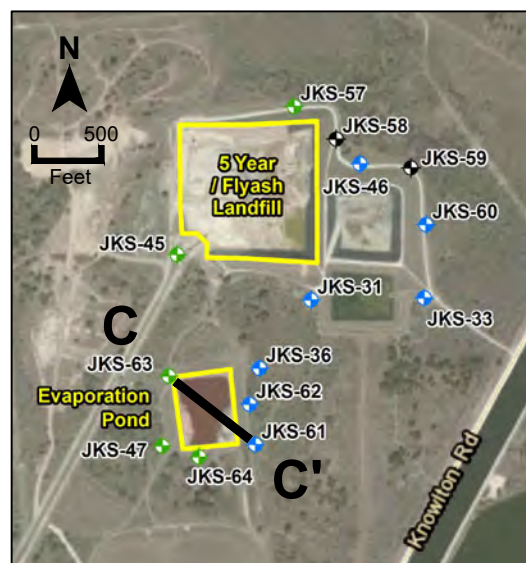
- LEGEND**
- SAND, SILTY SAND, AND/OR CLAYEY SAND
 - SILT, SANDY SILT, AND/OR CLAYEY SILT
 - LOW TO MEDIUM PLASTICITY CLAY, SANDY CLAY, AND/OR SILTY CLAY
 - HIGH PLASTICITY CLAY
 - INTERBEDDED SAND, AND CLAY

- POTENTIOMETRIC SURFACE (MEASURED DECEMBER 6, 2016)
- INITIAL GROUNDWATER LEVEL ENCOUNTERED DURING WELL INSTALLATION

Based on the review of the *CCR Units – 2017 Annual Inspection and Fugitive Dust Control Report* and as-built drawings, the elevation of the base of the BAPs ranges from 488 to 489 feet above msl. Stratigraphic cross sections (Section D-D' and Section F-F') depicting the pertinent elevations are provided as **Figure 6** and **Figure 7**, respectively. Although groundwater is under artesian conditions and rises to an elevation between 485 and 486 feet above msl based on available water level data, the first groundwater beneath the South BAP was encountered during well drilling at approximately 476 feet above msl. Based on geotechnical analysis, the unit that overlies the first groundwater consists of clayey sand, which typically has a hydraulic conductivity in the 10^{-6} to 10^{-8} cm/sec range signifying a low permeability unit. Based on the above information, the base of the South BAP is greater than 5 feet above the uppermost aquifer and unlikely to be in intermittent, recurring, or sustained hydraulic connection with the uppermost aquifer.

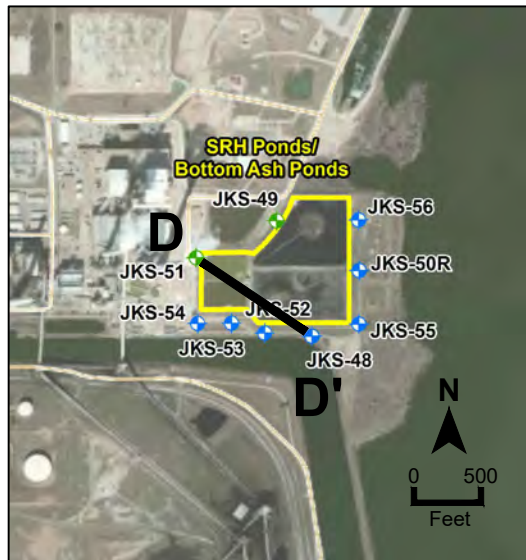
- SAND, SILTY SAND, AND/OR CLAYEY SAND
- SILT, SILTY SILT, AND/OR CLAYEY SILT
- LOW TO MEDIUM PLASTICITY CLAY, SANDY CLAY, AND/OR SILTY CLAY
- INTERBEDDED SAND, SILT, AND CLAY
- BEDROCK (SANDSTONE)

- LEGEND**
- POTENTIOMETRIC SURFACE (MEASURED DECEMBER 6, 2016)
 - INITIAL GROUNDWATER LEVEL ENCOUNTERED DURING WELL INSTALLATION
